White Hill Wind Farm

# Natura Impact Statement

White Hill Wind Limited

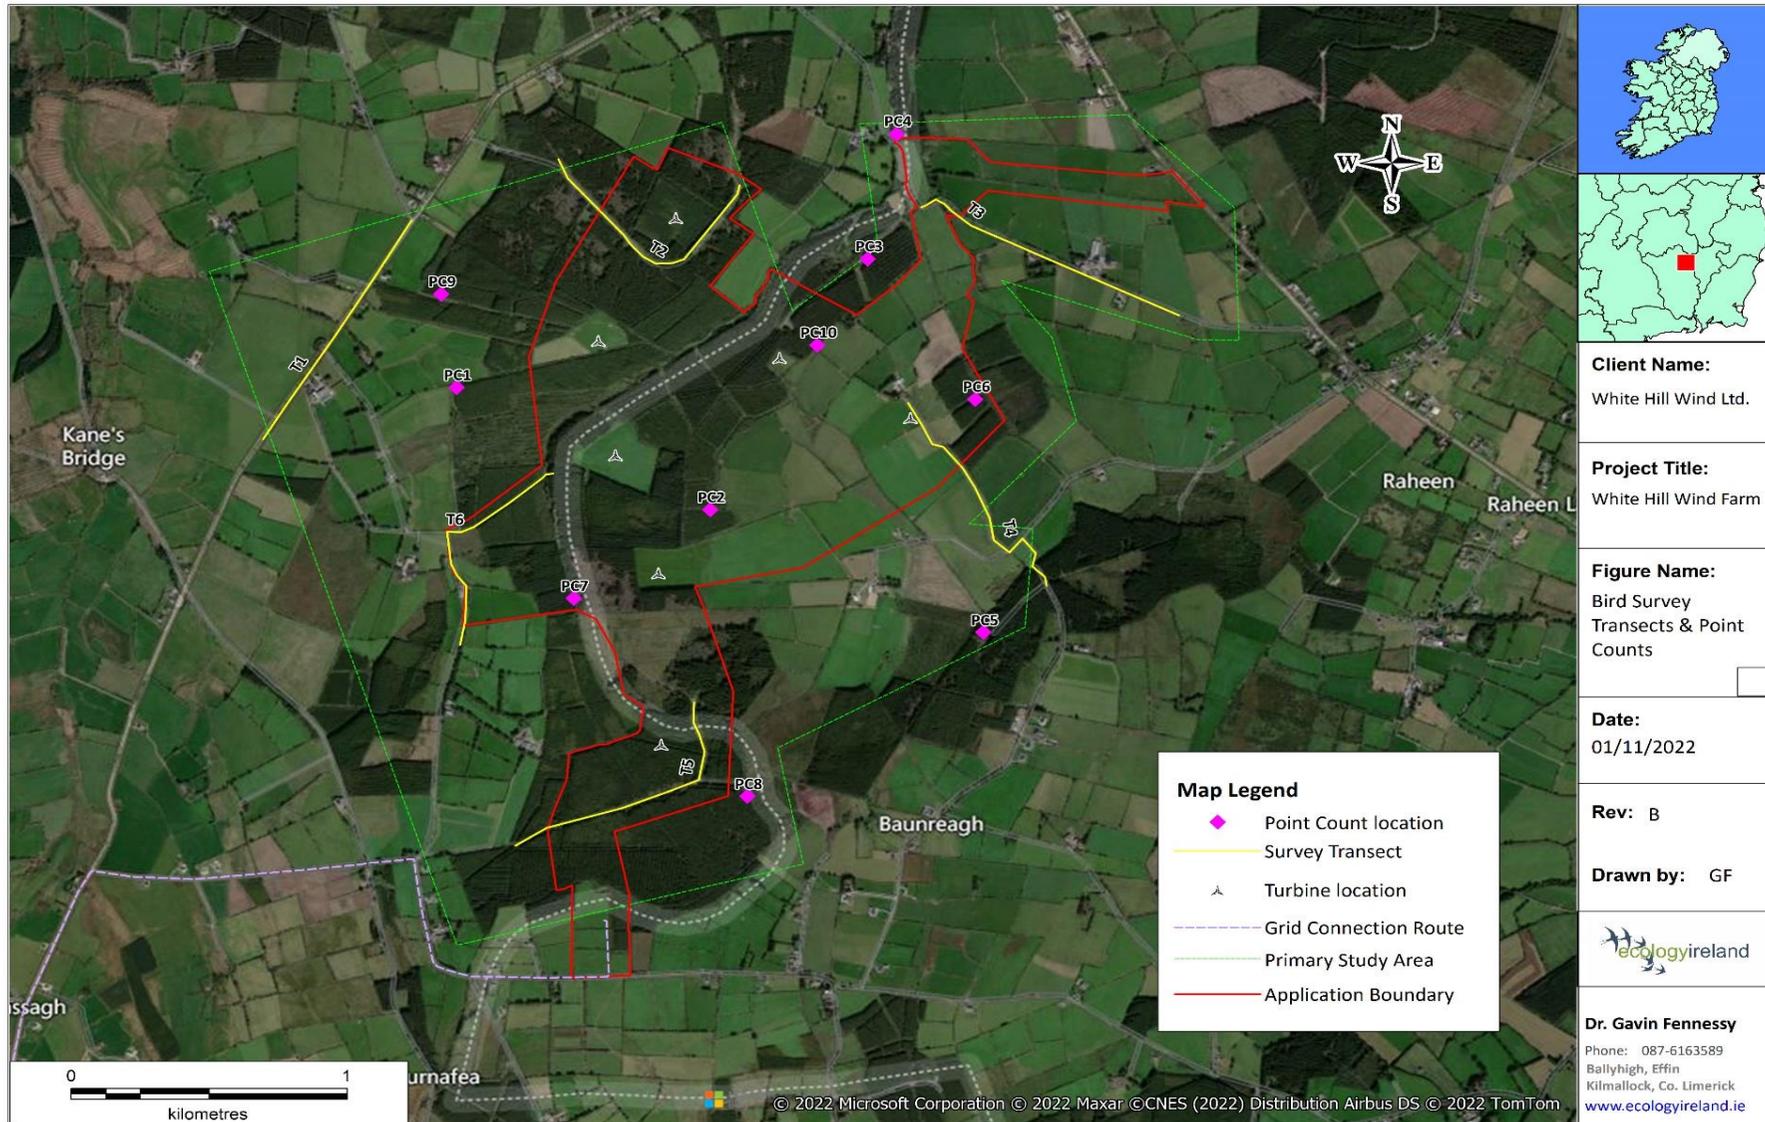
Figure 5.5: Bird Survey Transects and Point Counts.

Standard general breeding and winter season bird transect and point count surveys (Bibby *et al.* 2000) were undertaken at the biodiversity study area as follows (**Figure 5.5**; with a total of 6 no. transects and 10 no. point counts used).

Breeding and winter bird communities in the area were also recorded using standard belt transect and point count methodologies. The location of the transects and point counts is illustrated at Figure 5.5. Detailed results from the transects and point count surveys are presented at **Annex 5.4**.

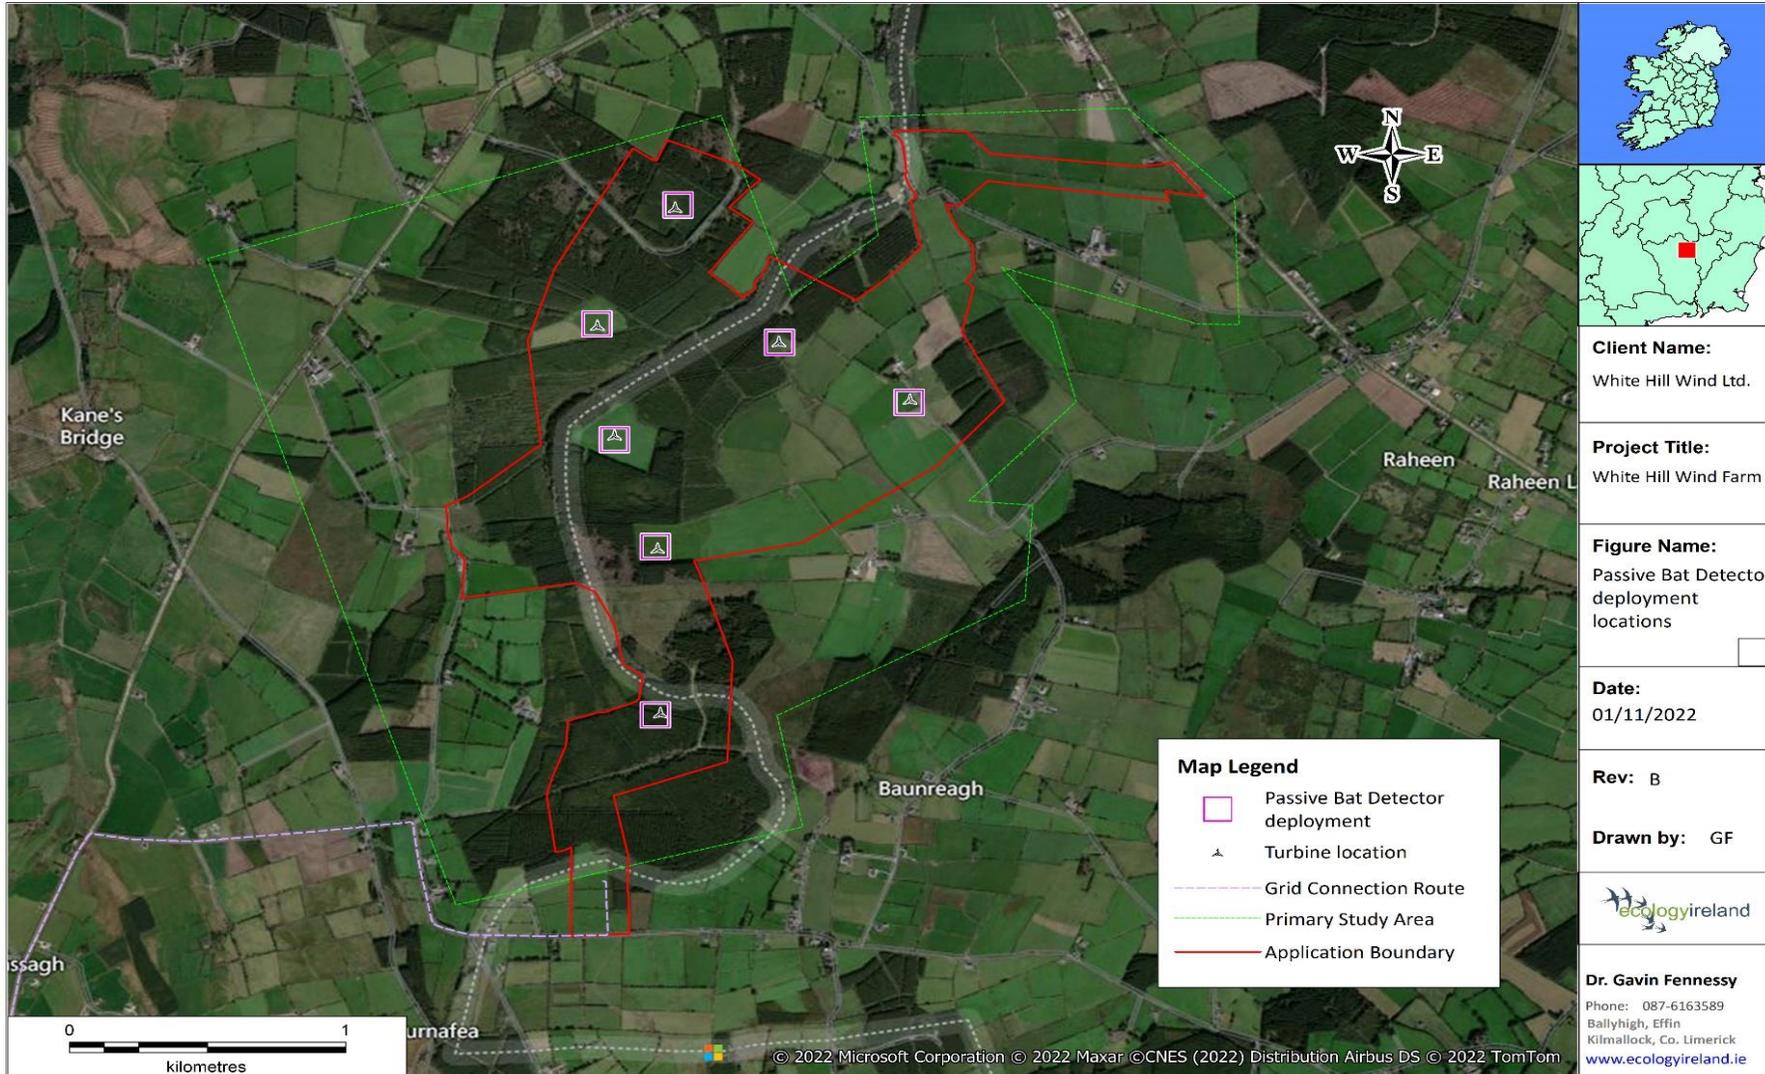
Figure 5.7: Passive Bat Detector Deployment Locations

detectors were deployed in the area from Spring 2021 up to Autumn 2021 (**Figure 5.6 & Figure 5.7**).

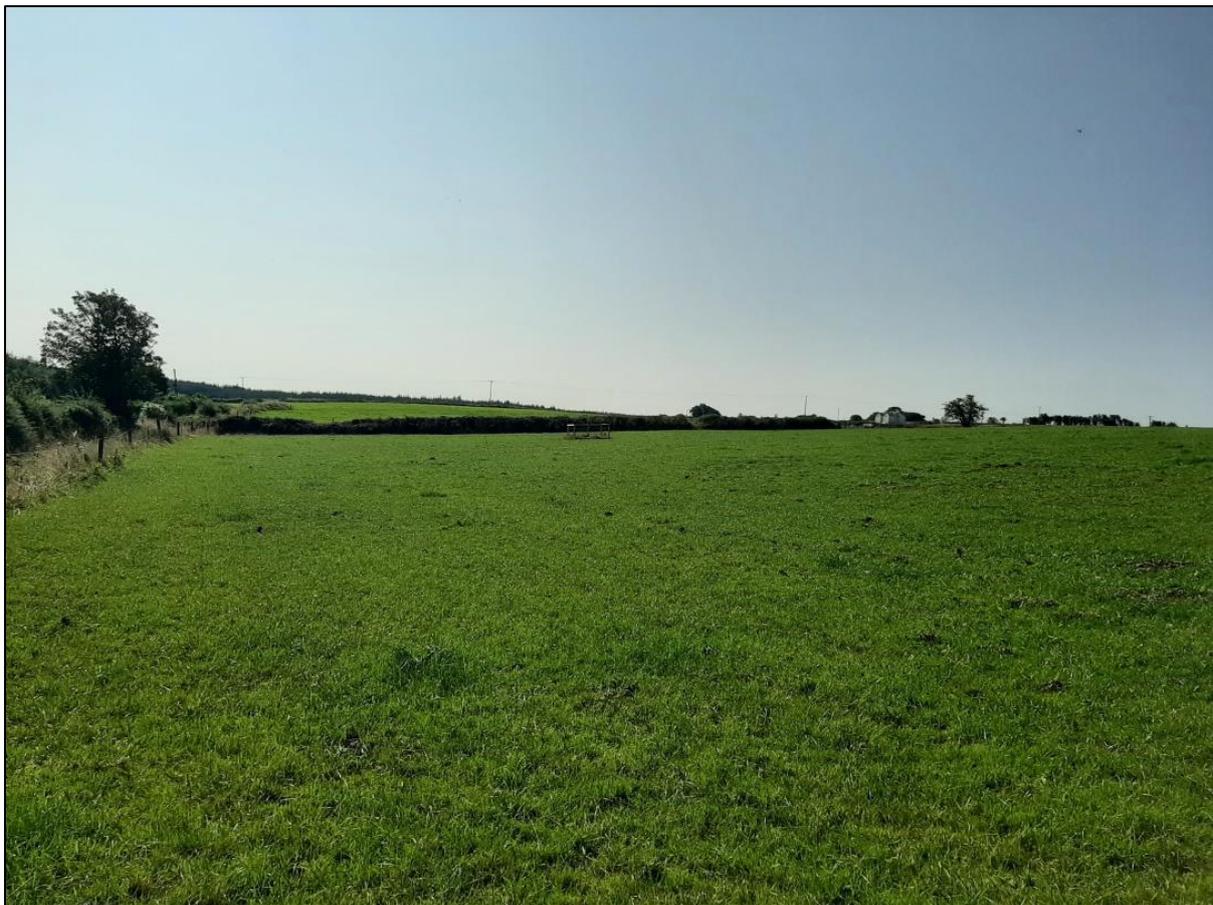
**Plate 5.1: Improved Agricultural Grassland (GA1)**

One of the dominant habitats within the study area is Improved Agricultural Grassland (GA1) and the majority of the wind farm infrastructure is located within this habitat type. Improved Agricultural Grassland is intensively managed or highly modified grassland that has been reseeded is regularly fertilised and grazed and/or used for silage making. Species composition included abundant Perennial rye *Lolium perenne* grass and other occasional grass species including Yorkshire fog *Holcus lanatus*, Creeping bent *Agrostis stolonifera*, annual meadow grass *Poa annua* and Meadow foxtail *Alopecurus pratensis*, and Crested dogs-tail. Relative abundance of the different grass species varied in different fields depending on the grazing regime and level of grassland management. In some areas where there was more extensive cattle

Improved Agricultural Grassland (GA1) is evaluated as being of Local Importance (Lower Value) due to its intensively managed nature albeit in less intensively managed fields the improved grassland did support a greater variety of botanical species.

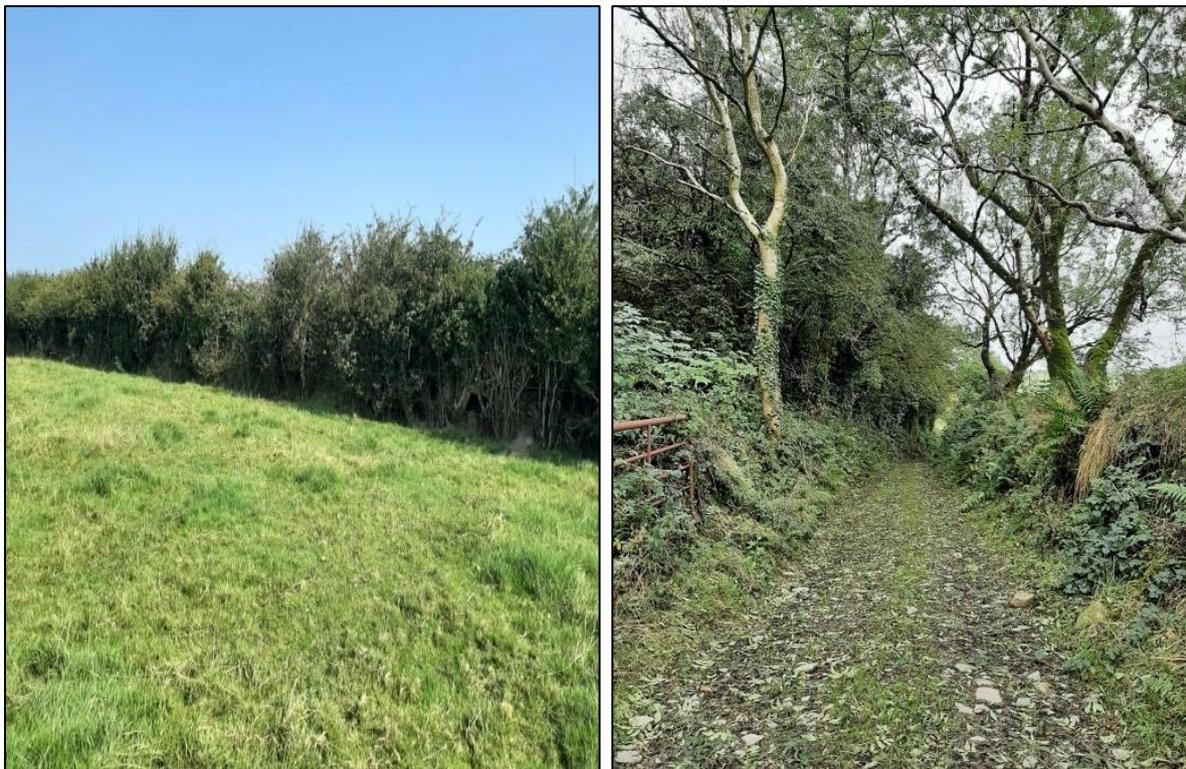
**Plate 5.2: Hedgerows (WL1)**

Hedgerows are well established across the study area and formed the natural livestock proof boundaries along the agricultural grassland fields. Active management of the hedgerows was evident in many places and included cutting of hedgerows to c 2-3m high with some intermittent trees allowed to remain in places. This was particularly evident along farm tracks and public roads. Elsewhere the hedgerows have been allowed to grow and management was less intense, these hedgerows were generally 4-5m in height with trees such as Sycamore *Acer pseudoplatanus*, Ash *Fraxinus excelsior* and Whitethorn *Crataegus monogyna*. The shrub layer consisted of frequently occurring Bramble *Rubus fruticosus* agg. and Gorse *Ulex europaeus*. The quality of hedgerows and species composition within them varied across the study area; in places the hedgerows were species poor and gappy and in other areas hedgerows were mature and long established with a good variety of species which included ferns and bryophytes. A notably mature hedgerow was recorded along an existing farm track in the northeast of the study area leading to an

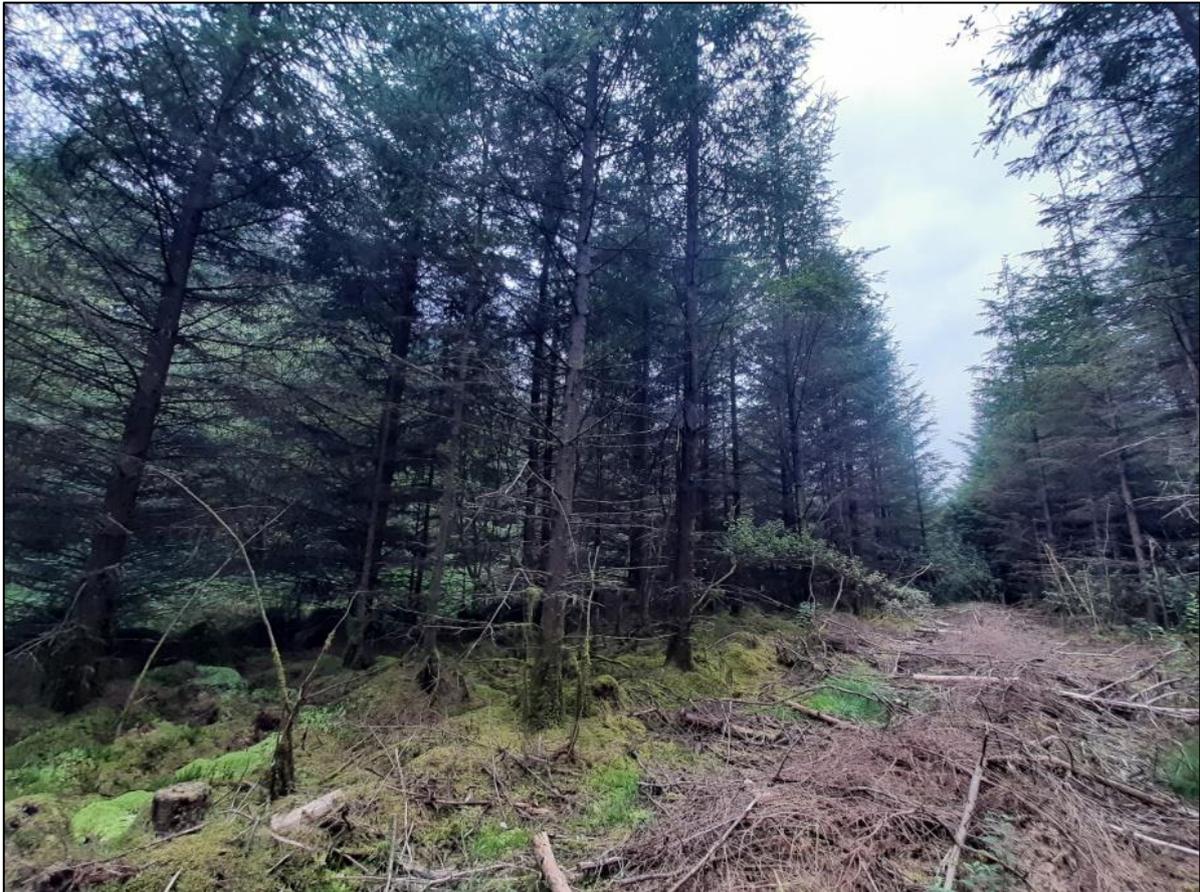
**Plate 5.3: Conifer Plantation (WD4)**

Large blocks of commercial conifer plantations (WD4) of various age classes occur throughout the wind farm study area. The commercial conifer plantation consists predominately of 1<sup>st</sup> rotation plantations which are at various stages of maturity. The age classes present are dominated by blocks of mature and semi-mature closed canopy plantations (**Plate 5.3**). The conifer plantations present are typically species poor; dominated by regular, uniform stands of commercial timber tree species including Sitka Spruce *Picea sitchensis*. Along some of the conifer plantation edges, a narrow band of deciduous tree species such as Alder *Alnus glutinosa*, Beech *Fagus sylvatica* and Birches (e.g. Silver Birch *Betula pendula* and Downy Birch *B. pubescens*) have also been planted.

The conifer plantation ground flora is typically poor but includes occasional Common Bent *Agrostis capillaris*, Wood Sorrel *Oxalis acetosella* and mosses such as *Rhytidiadelphus squarrosus*, *Hypnum jutlandicum* and *Thuidium tamariscinum*. The ground flora can be mostly found along the plantation edges as; away from the edge towards the centre of the forest; the canopy closes in, light levels are much reduced and the ground layer consists predominately of a dense layer of dead and decaying conifer leaf litter. Narrow verges of semi-natural wet grassland (GS4; as described below) also persist along drainage channels adjacent to the conifer plantation.

Commercial conifer plantations are highly modified habitat types which are species poor and dominated by uniform stands of commercial timber species (e.g. Sitka Spruce) and, as such, are of Local importance (lower value).

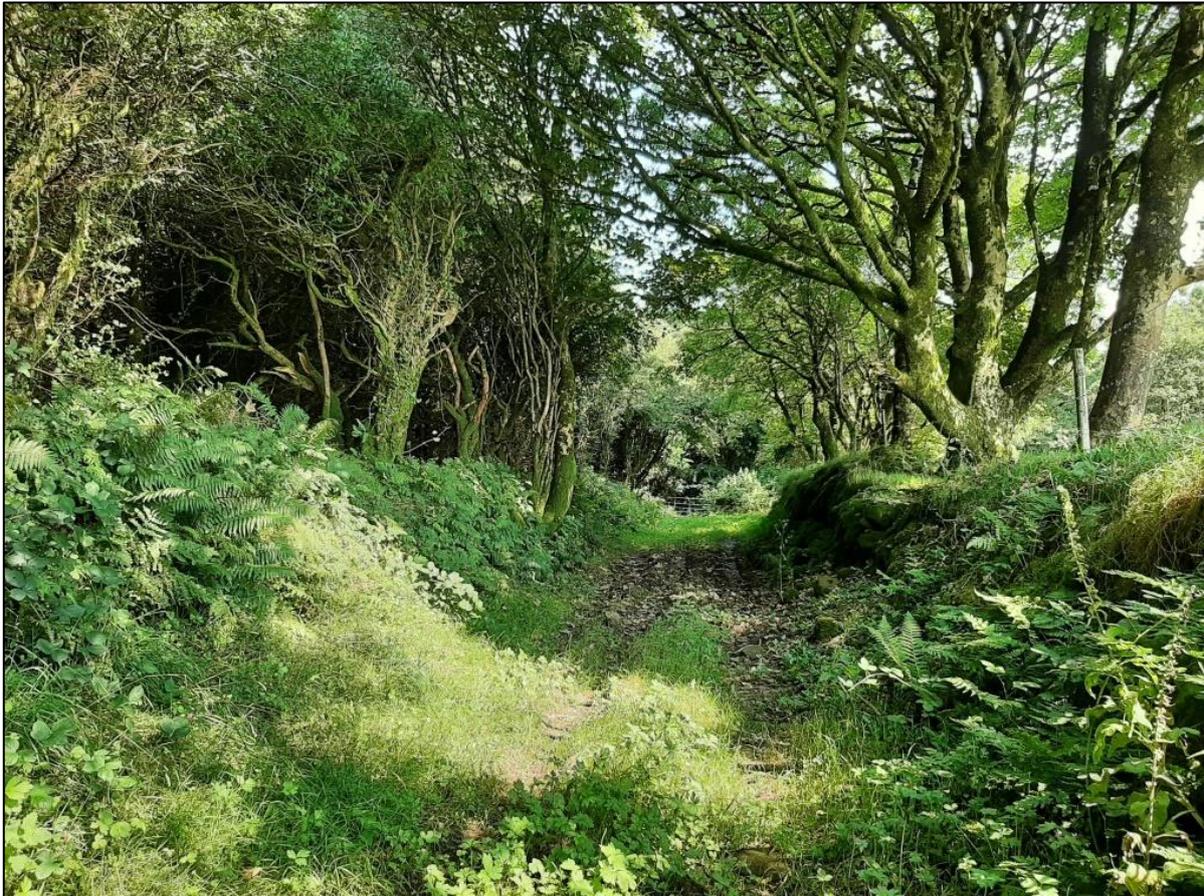
**Plate 5.4: Treelines (WL2)**

Treeline habitat (WL2) occurred in places within the study area, albeit hedgerows were largely low growing. The main concentrations of treelines were recorded in the northeastern part of the wind farm site largely around farm settlements or along farm tracks and public roads.

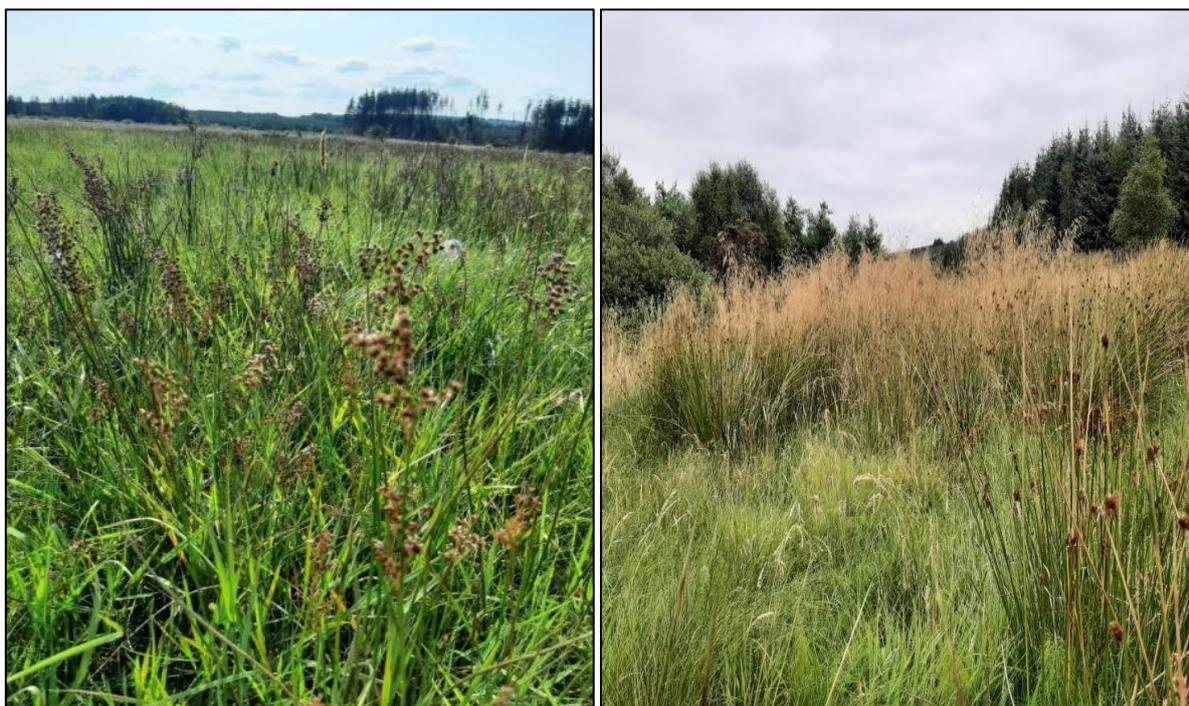
**Plate 5.5: Wet Grassland (GS4)**

Wet Grassland (GS4) is described as wet or waterlogged mineral or organic soils that are poorly-drained or, in some cases, subjected to seasonal or periodic flooding. On sloping ground, wet grassland is mainly confined to clay-rich gleys and loams, or organic soils that are wet but not waterlogged. In the study area, Wet Grassland (GS4) habitat type occurred largely in the north central and western part of the site where the Knockbrannagh and Knockbaun stream runs. Several man-made drains for agriculture and forestry have been cut along the perimeter of the fields in this area however the vegetation indicates that ground conditions are still moist. Many of the wet grassland fields appear to have been improved but are reverting to a more semi-improved wet grassland type due to the moist ground conditions. The habitat is composed of abundant Soft rush *Juncus effusus* and frequently occurring Creeping buttercup, White clover, Yorkshire fog, Crested dogs tail, Creeping bent, Common sorrel, Broad leaved Dock, Creeping bent. Occasionally occurring species included Sharp-flowered rush *Juncus acutiflorus*, Cuckoo flower *Cardamine pratensis*, Common mouse ear *Cerastium fontanum*, Meadow buttercup, Coltsfoot *Tussilago farfara*, Sweet vernal grass, Selfheal *Prunella vulgaris*, Marsh thistle *Cirsium palustre* and Catsear *Hypochaeris radicata*.

Wet Grassland (GS4) habitat located within the study area is evaluated as being of Local Importance (Higher Value). It is locally important for biodiversity as much of the surrounding grasslands have been converted to improved agricultural grassland. Wet grasslands and the water features (drains, water filled hollows) within this habitat provide important habitat for amphibians and invertebrates, which in turn provide food for breeding birds and their chicks, as well as bat species. The field where turbine T3, and its associated crane hardstanding and access track; will be located is a wet grassland type that is considered of higher ecological value due to the greater variety and type of species present. The species recorded here were also positive indicators for the Annex I grassland *Molinia* Meadows or 6410 *Molinia* meadows on calcareous, peaty or clayey silt laden soils (*Molinion caeruleae*). A similar habitat of high value wet grassland is also present along both sides of the stream in the northwest of the site.

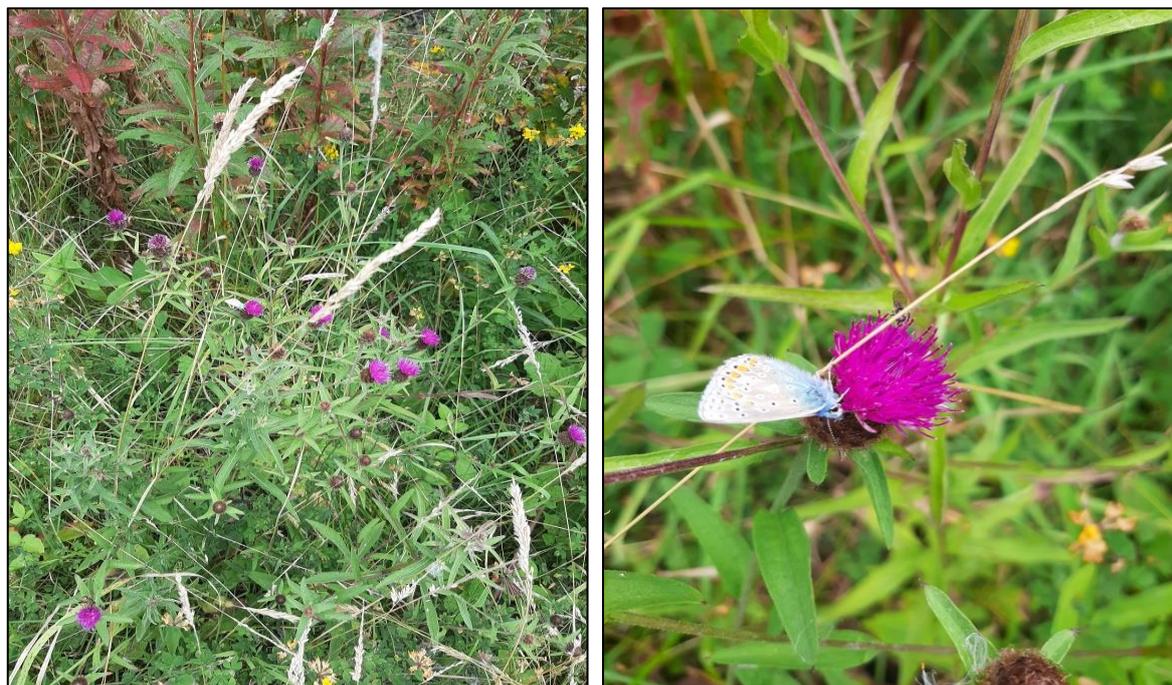
**Plate 5.6: Dry Meadows and Grassy Verges (GS2) habitat; Common Blue butterfly on Common knapweed**

Dry meadows that are rarely fertilised or grazed and are mown only once or twice per annum and can be seen most commonly on grassy roadside verges. Within the study area, the habitat was recorded along the coniferous forestry tracks and margins of the farm tracks. Species included grasses such as the frequently occurring Cocksfoot, Yorkshire fog, False oat grass and broadleaved plants such as Common knapweed and occasional Common birds foot trefoil, Eyebright, Marsh thistle, Rosebay-Willowherb, White clover, Red Clover, Selfheal and Ragwort.

The Dry Meadows and Grassy Verge (GS2) habitat is evaluated as being of Local Importance (Higher Value) due to the range of flowering plant species present in this habitat which are beneficial to local invertebrates and, in turn, are important components which support local biodiversity.

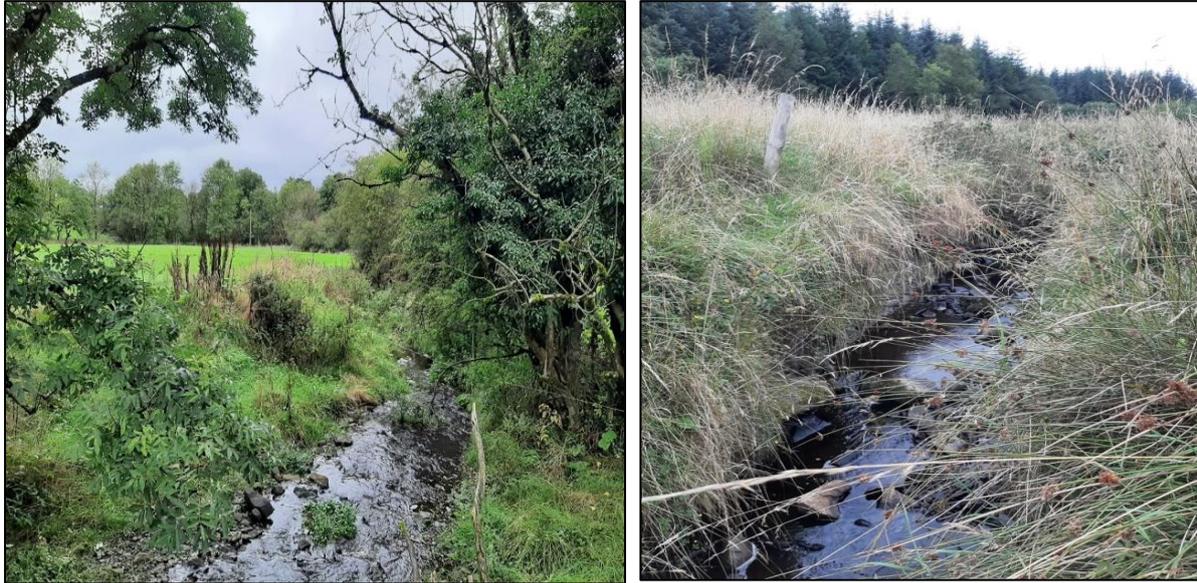
**Plate 5.7: Eroding Upland River (FW1)**

2 no. main streams flow through the study area; the Knocknabranagh & Knockbaun Stream and the Coolcullen Stream. The streams drain in a northerly direction and join together (Coolcullen River) before flowing into the River Dinin (South) which is itself a tributary of the River Nore and forms part of the River Barrow and River Nore SAC (002162). The streams are small in size, c. 1-3m wide, and shallow, c. 10-60cm of water.

The Upland Eroding River habitat is evaluated as being of Local Importance (Higher Value). While small in size, these linear aquatic and wetland habitats support specialist aquatic plant communities which enhance local biodiversity and function as eco-corridors. They also provide habitat to support amphibians and invertebrates, which in turn provide food for birds and their chicks as well as other fauna such as bat species. Eroding Upland Rivers can support habitat which corresponds to the EU Habitats Directive Annex I watercourses of plain to montane levels with the *Ranunculion fluitantis* and *Callitriche-Batrachion* vegetation (3260); however the streams within the study area do not support this Annex I habitat type.

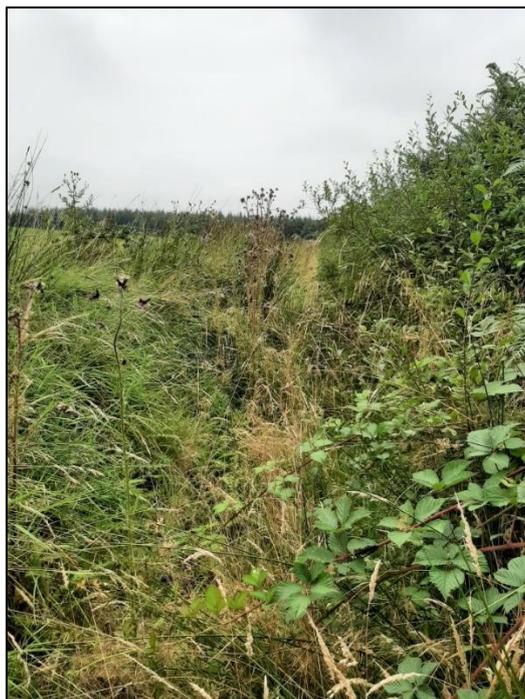
**Plate 5.8: Drainage ditch (FW4)**

A network of drainage ditches have been installed along the majority of the field boundaries across the study area as part of drainage measures for agricultural land improvements and for commercial afforestation. Many of the drains were dry and overgrown or had a muddy base with species assemblage composed of grasses such as the frequently occurring Yorkshire fog, Cocksfoot, Soft rush and Creeping buttercup with occasional Bramble, Rosebay willowherb, Marsh thistle, Tufted-hair grass, Aquatic ragwort and Nettle. In more moist drains, Round-leaved water crowfoot and Floating sweet grass were recorded.

The Drainage Ditch habitat is evaluated as being of Local Importance (Lower Value). While these habitats are valuable in supporting aquatic flora and fauna, they are routinely cleared and, due to the disturbed nature of the habitat, they are classified as being of local importance with lower ecological value.

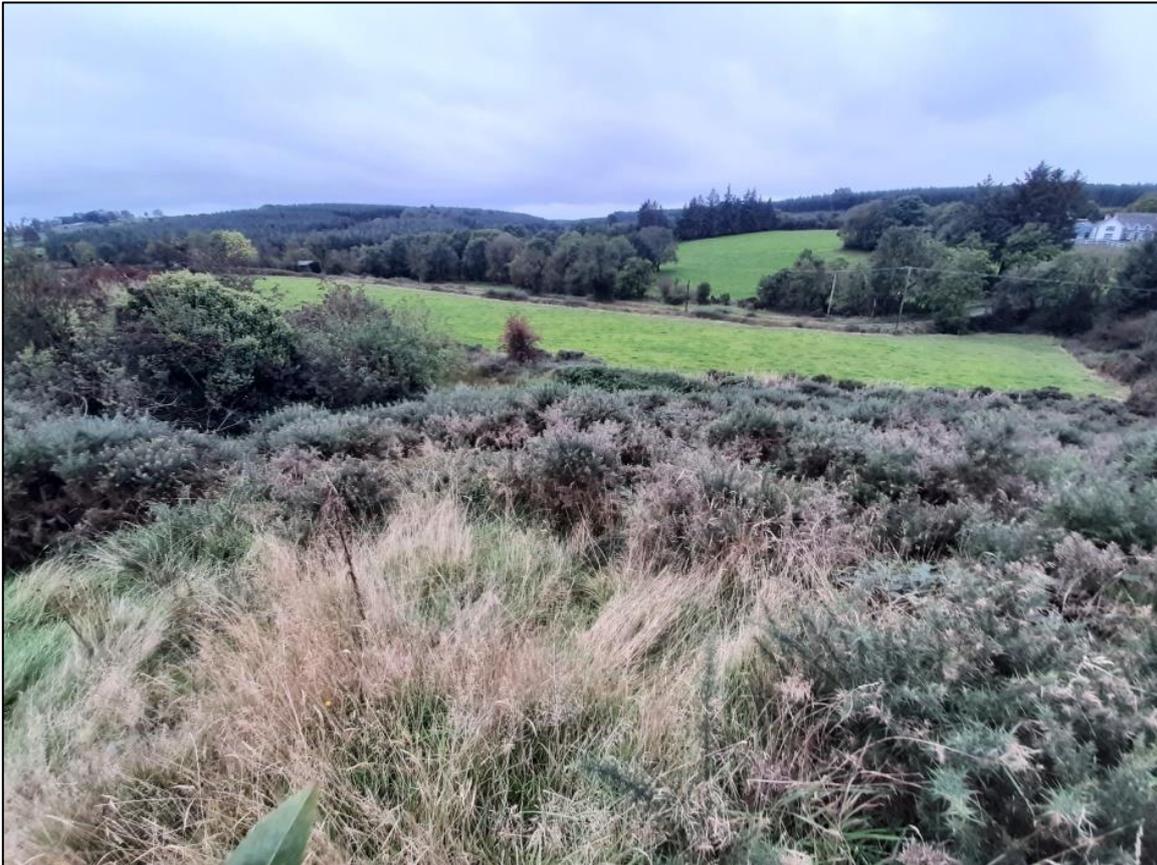
**Plate 5.9: Scrub (WS1)**

Scrub is a habitat type dominated by at least 50% cover of shrubs, stunted trees or brambles. The canopy height is generally less than 5m, or 4m in the case of wetland areas. Scrub habitat was recorded within the study area near the site entrances in the northeast of the wind farm, along margins and firebreaks of coniferous forest plantation and within the proposed borrow pit to the northeast of the wind farm. Species recorded within the scrub habitat included frequently occurring Grey willow, Gorse, Bramble, Blackthorn and Hawthorn. Herbaceous species included frequently occurring Yorkshire fog, Marsh thistle, Nettle, Creeping bent, occasionally occurring Devils bit scabious *Succisa pratensis* and rarely occurring Broom *Cytisus scoparius*.

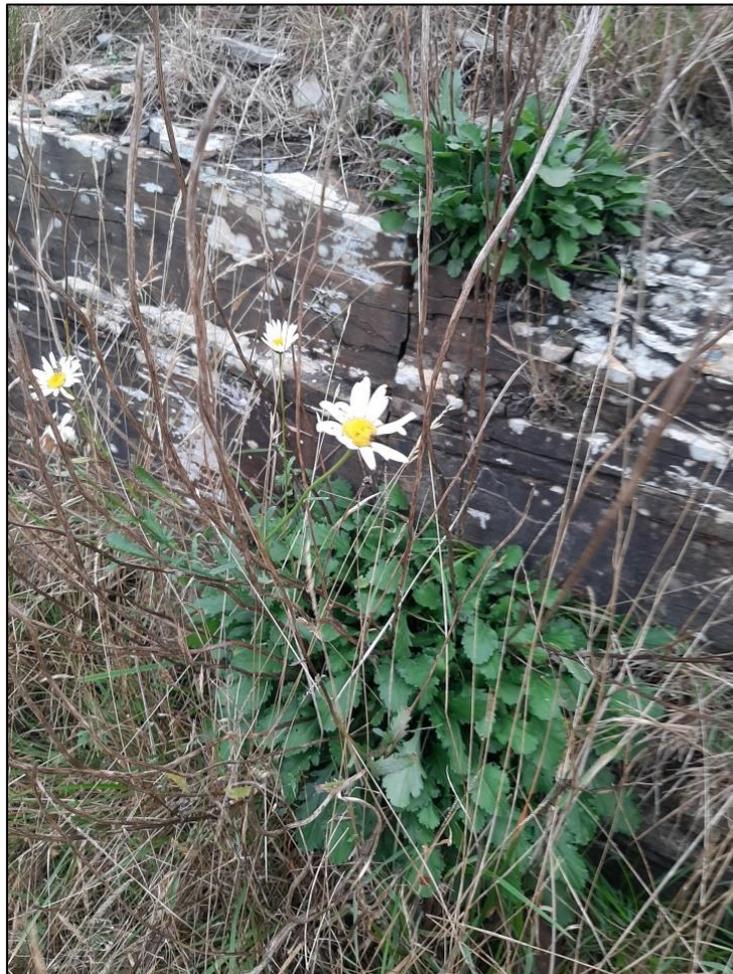
**Plate 5.10: Exposed Siliceous Rock (ER1)**

A small area of exposed rock was recorded within a former quarry (now proposed as a borrow pit) in the northeast of the wind farm site. This area is now mostly overgrown, with Wet Grassland (GS4) and Scrub (WS1) habitat dominating. Mosses such as Pointed-spear moss *Calliergonella cuspidata* and *Fiscidians* spp. occasionally occurred. The lichen *Ochrolechia parella* was also growing on the rock face. Plant species colonising crevices in the rock face included Ox-eye daisy, Red fescue and Creeping bent grass.

Exposed Siliceous Rock is evaluated as being of Local Importance (Lower Value).

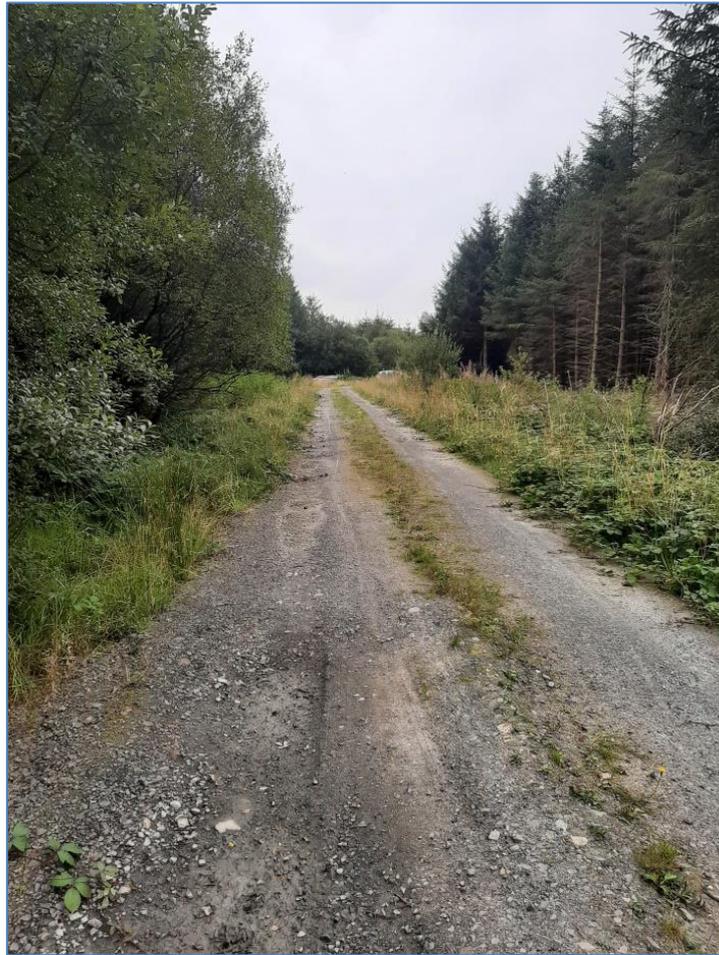
**Plate 5.11: Spoil and bare ground (ED2) along existing forestry track**

The spoil and bare ground habitat (ED2) was largely located along the extensive network of farm and forestry tracks that are located throughout the study area. This bare ground area consisted of mud tracks or tracks with hardcore gravel laid along them. In places, the tracks had a strip of low growing vegetation running along the centre including frequent Yorkshire fog, Creeping bent, Annual meadow grass, Dandelion and Daisy. The majority of the access tracks present are regularly maintained/disturbed; and, due to the level of management and/or disturbance, there is little or no vegetation present on the main tracks. However, along track edges, which are subjected to less ongoing disturbance, vegetation has begun to recolonise in parts forming Dry Meadows and Grassy Verges (GS2) habitat type.

The Spoil and Bare Ground habitat present is a modified habitat type persisting as a result of resurfacing works and or ongoing maintenance (**Plate 5.11**). However, where vegetation has begun to re-establish (e.g. Recolonising Bare Ground (ED3)); along the centre and edge of tracks or in areas subject to lower disturbance levels; opportunities for wildflowers and plants of pollinator value to grow are introduced including occasionally occurring Common Knapweed, Common birds-foot trefoil, Pine-apple weed, Daisy and Colts-foot.

The Spoil and Bare Ground habitat is evaluated as being of Local importance (Lower value) ecological value.

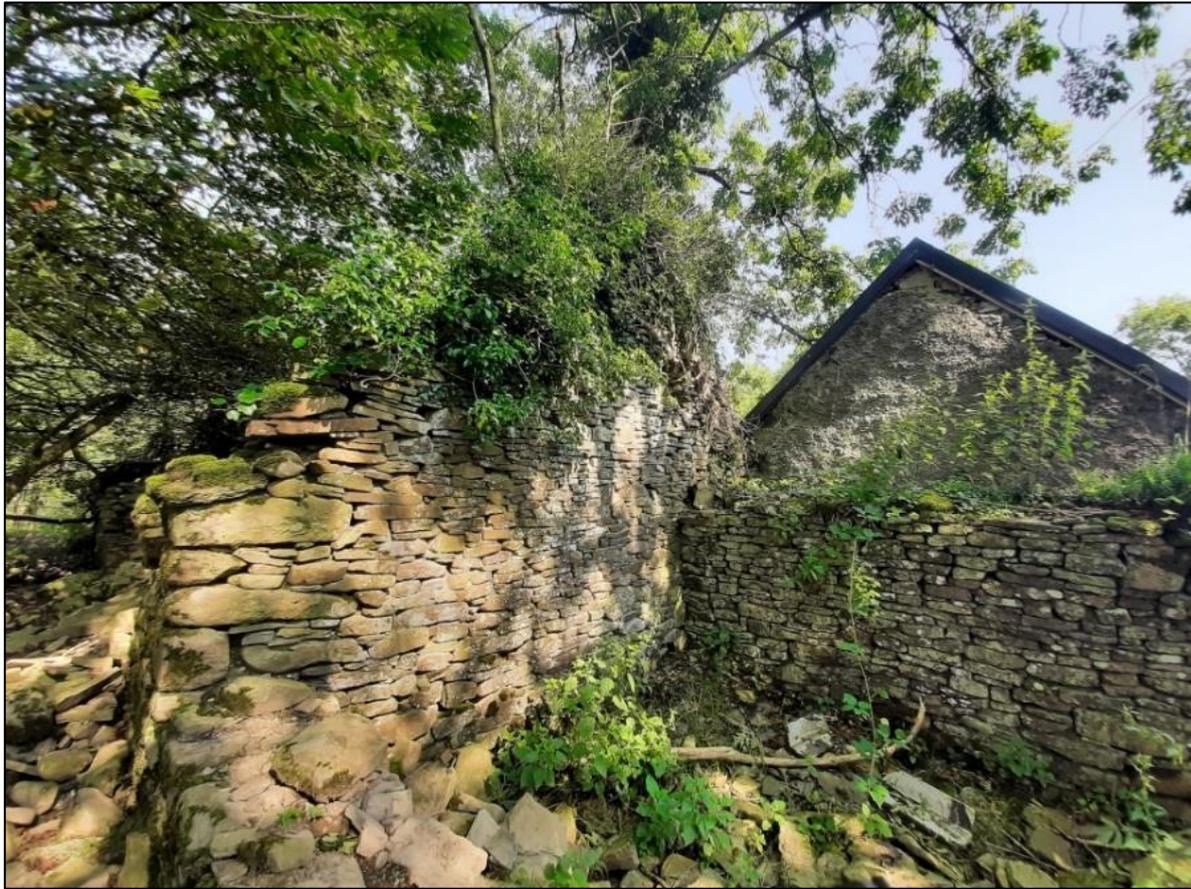
**Plate 5.12: Stone Walls and Other Stonework (BL1)**

This category incorporates stone walls and most other built stone structures in rural and urban situations, apart from intact buildings (Fossitt, 2000).

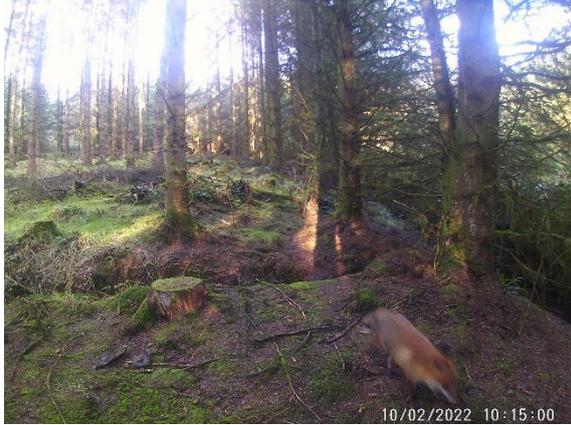
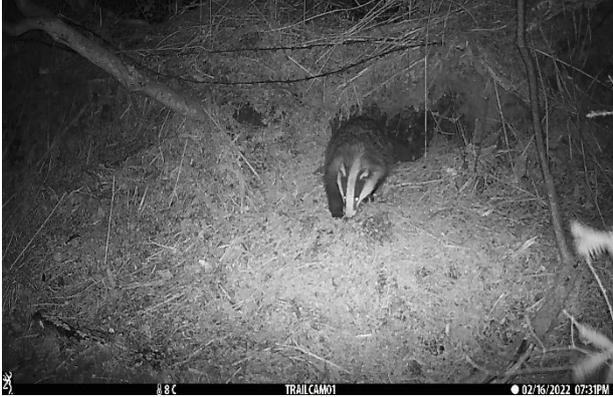
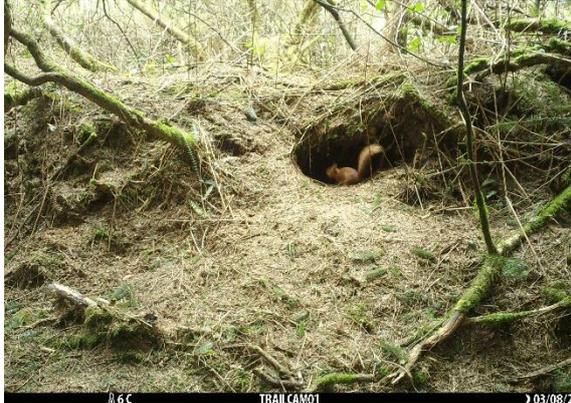
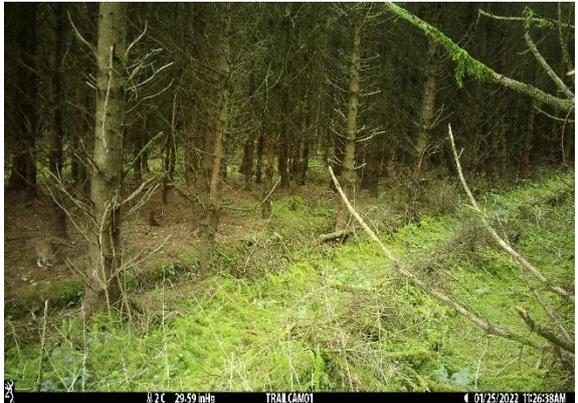
**Plate 5.13: Sample Images captured by Trail Cameras**

<p>Two Badgers grooming. Cam_2.</p>	<p>Pine Marten recorded at outlier sett 'Sett_A' (location not disclosed).</p>

<p>Red Fox. Cam_5.</p>	<p>Badger exiting outlier sett 'Sett_A' (location not disclosed).</p>

<p>Red Squirrel at outlier sett 'Sett_A' (location not disclosed).</p>	<p>Irish hare. Cam_1.</p>

2 no. badger setts were identified and, in both cases, are outlier setts located proximal to access tracks to be constructed as part of the project. The locations of setts are not identified in this report, but images of the sett entrances are illustrated at **Plate 5.13**. These showed signs of occasional use and are typically located at a distance from the primary setts. They, like other secondary and tertiary setts, can be quiescent for prolonged periods and some are completely abandoned.

Examples of the mammal images captured by trail cameras at the proposed site are provided at **Plate 5.13** below.

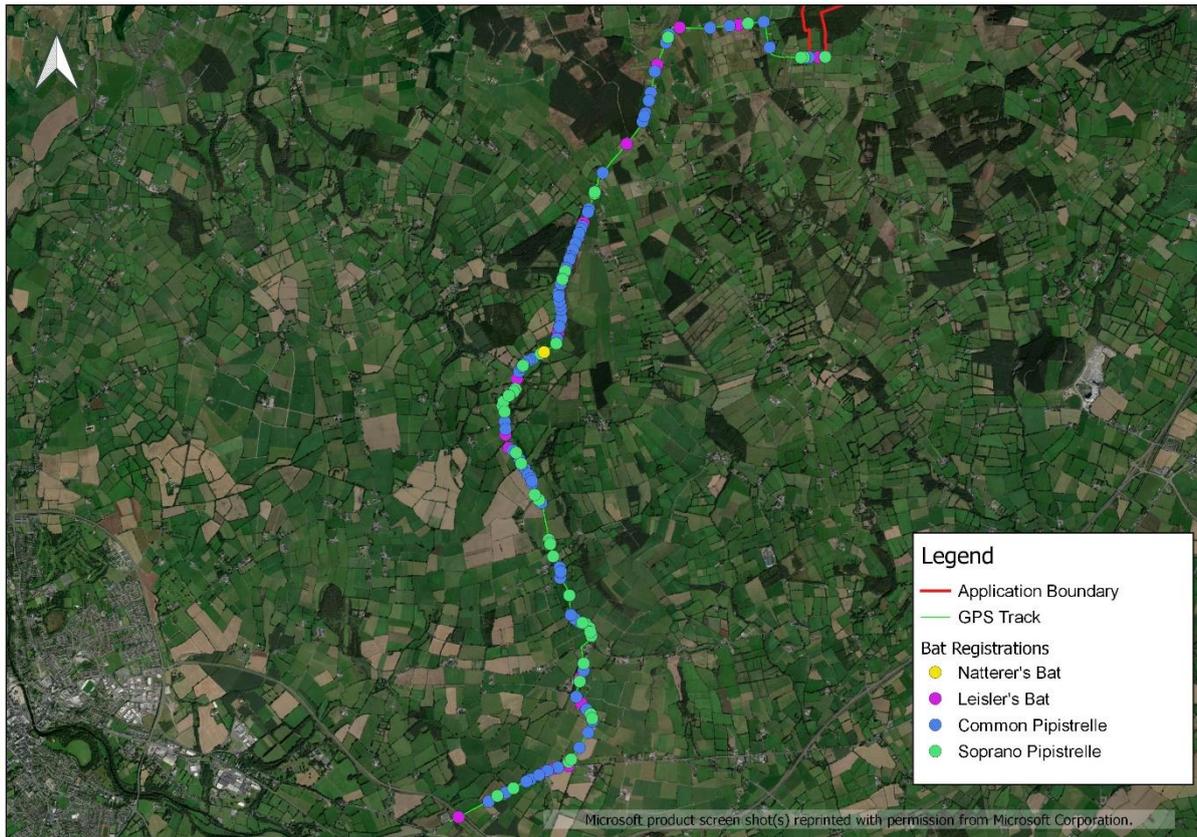
**Figure 5.15: Results of Active Bat Surveys along the Grid Connection Route**

The diversity of species recorded during active bat surveys along the grid connection route (**Figure 5.15**) was similar to the species diversity recorded on the wind farm site. For all species recorded along the grid connection route, the activity recorded was generally positively correlated with the presence of mature trees and large and structurally diverse hedgerows along the roadside.

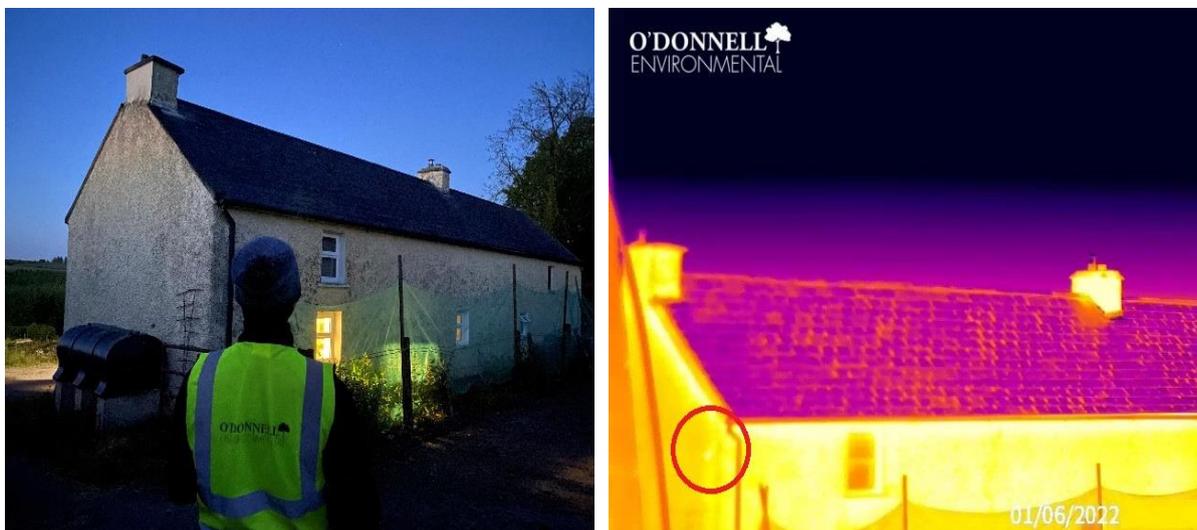
Residence and Farm Building at B\_38 during emergence survey.

Bat emergence (circled in red) at B\_38 captured on thermal imaging camera.

Roosting was confirmed at the B\_38 structure during the emergence survey on 1 June 2022. A single Soprano Pipistrelle was observed emerging from the gable at 22:06pm (see **Figure 5.16; Plate 5.14**). There was no evidence of any additional roosting at this location or the presence of a significant roost such as a maternity roost.

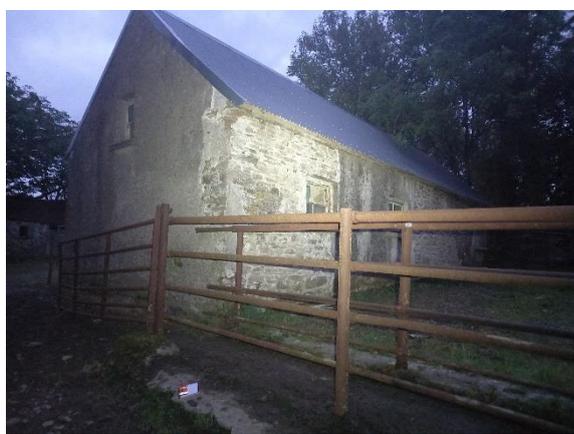
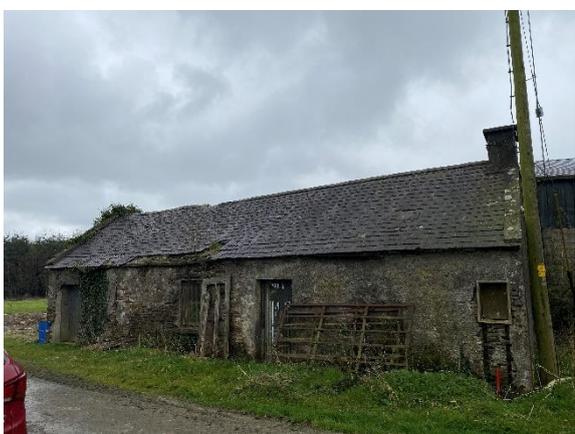
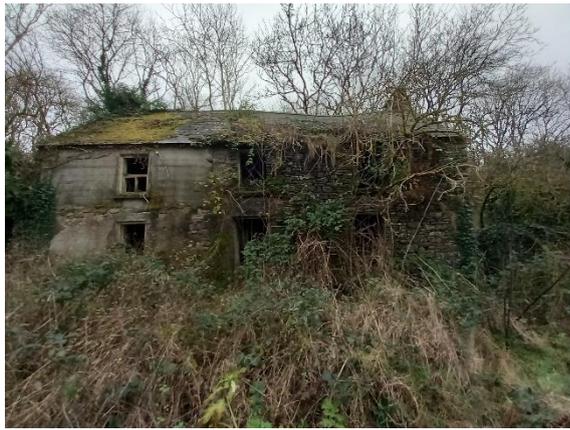
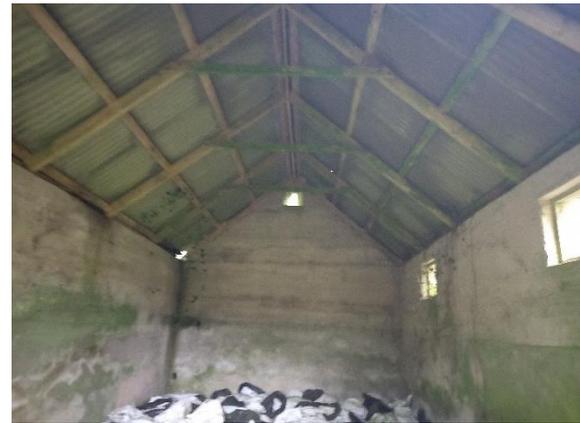
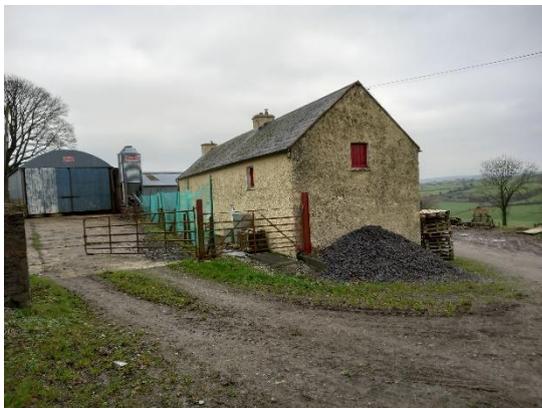
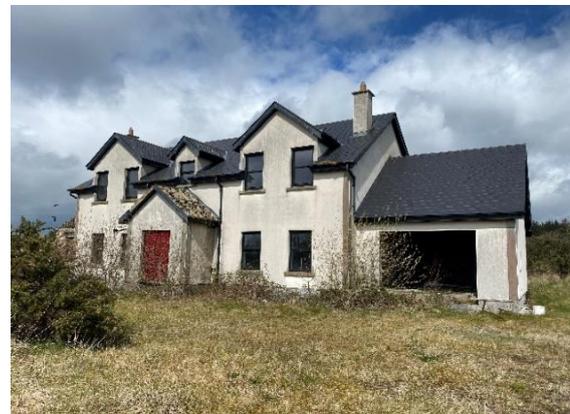
**Plate 5.15: Selection of the PRFs Inspected**

Building at B_37	Building at B_30

Building at B\_06

Interior of a building at B\_06

Farm Building at B\_38

Abandoned Residence at B\_25

proposed works were identified. Descriptions of the relevant PRFs is provided in **Table 5.33** below. Images of these PRFs are shown in **Plate 5.15**.
