White Hill Wind Farm

# Natura Impact Statement

White Hill Wind Limited

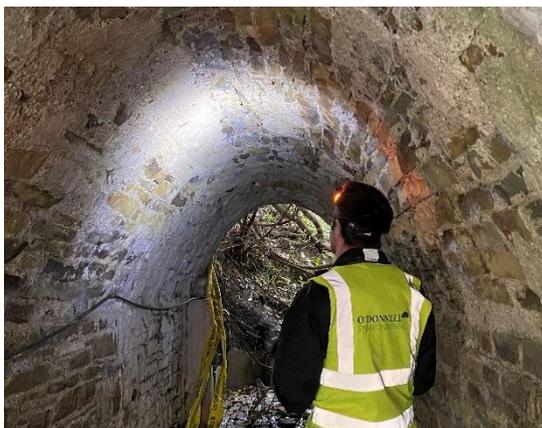
Inspection of Bridge 2.

Ref.	Description	Suitability for roosting bats	Easting (ITM)	Northing (ITM)
Culvert 1 & 2	Plastic pipe.	Negligible	657837	656636
Culvert 3	No significant structure present.	Negligible	657484	658019
Bridge 1	Single culvert. Structure provides approx. 500mm above normal water level. Some minor PRFs present but lack of height reduced value to bats.	Low	657312	658685
Bridge 2	Structure provides little gap to normal water level.	Negligible	656828	660149
Bridge 3	Single arch stone structure, approx. 2m height. Some minor crevices present. No evidence of roosting bats.	Low	657115	660610
Culvert 4&5	No significant structure present.	Negligible	660358	664568

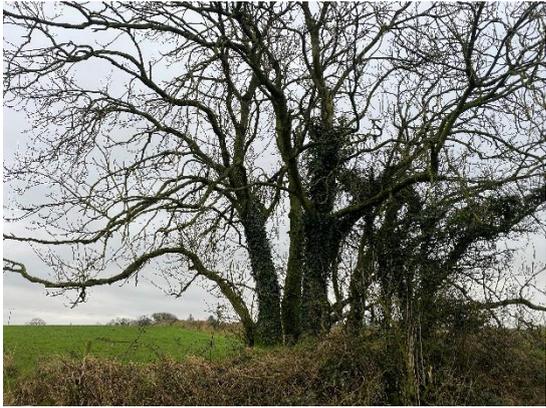
<p>Tree T_02.</p>

for roosting by bats. 2 no. trees were identified with some suitability (i.e. above 'negligible' suitability) to be used by roosting bats; however, neither will be directly affected by the project (**Table 5.32; Figure 5.17**).

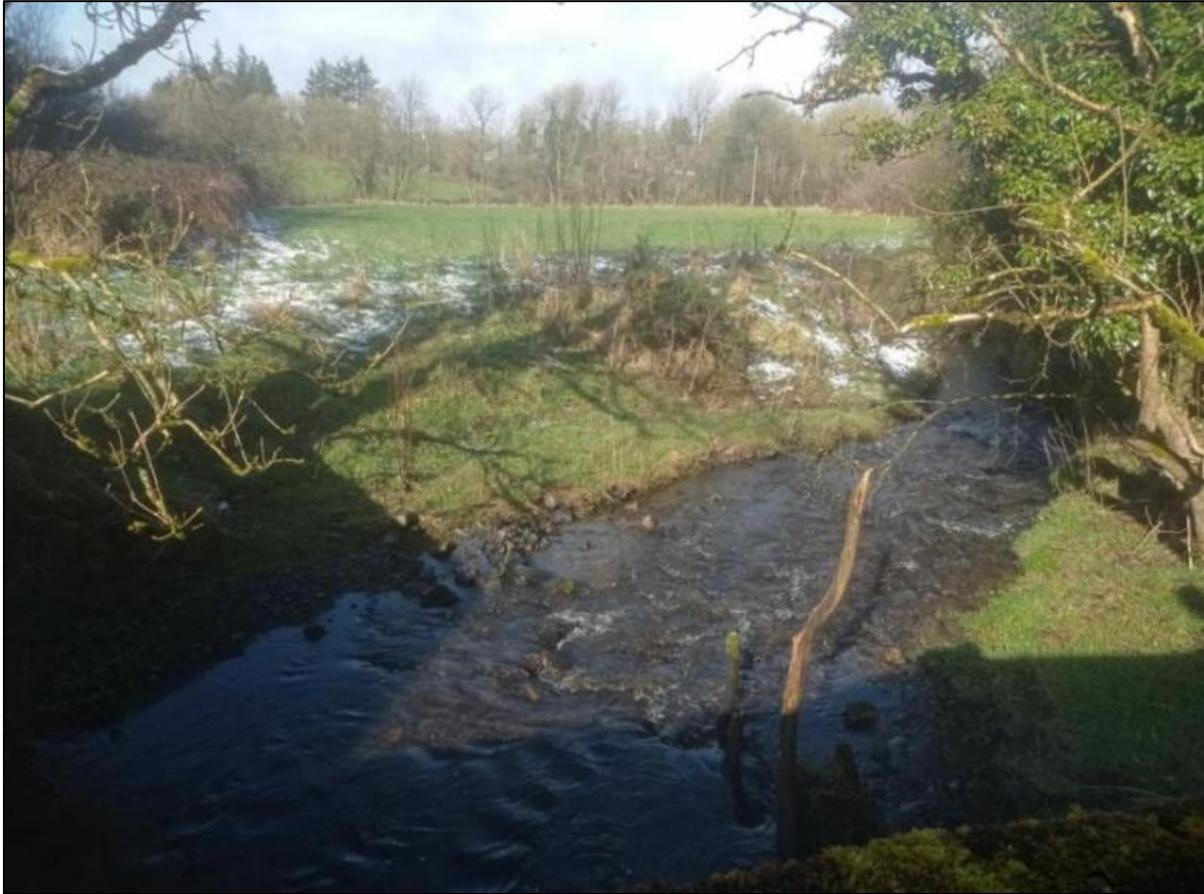
**Plate 5.16: Coolcullen Stream as it leaves the Project Site (image captured during high water levels)**

In terms of fisheries habitats, there are some holding pools and spawning areas for adult trout. These are largely free of siltation and hence an oxygen rich intra-gravel zone is available for the development and refuge of eggs and alevins. Rearing areas for juvenile salmonids are plentiful, and this is reflected in the findings of the fish survey below. The stream is considered to be too small for spawning adult salmon. There is some reasonable eel habitat with submerged large stones and overhanging banks.

There is almost no stable optimal lamprey ammocoete habitat within this section of the watercourse; it is limited by the stream's high energy nature.

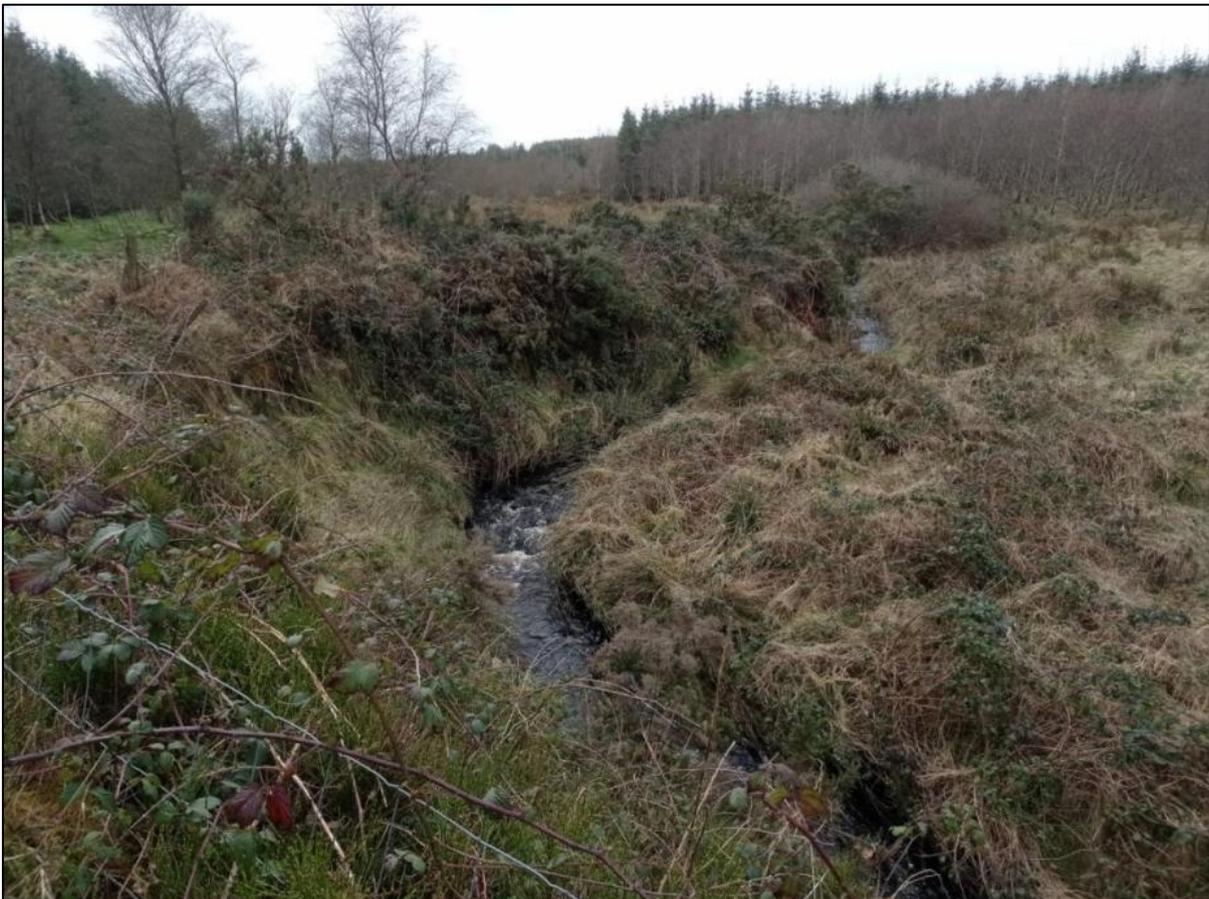
**Plate 5.17: Knocknabranagh & Knockbaun Stream within the Project Site**

lamprey ammocoete habitat within this section of the watercourse; it is limited by the stream's high energy nature and low fine sediment input.

Riparian vegetation in the middle and lower section is mainly overhanging rush and bramble often characteristic of these upland streams. In general, it is shallow set within its floodplain, which offers very good connectivity with the floodplain. Various wetland habitats border the stream throughout the stretch of stream draining the proposed development site. These exclude livestock from the watercourse while also attenuating nutrients and buffering the amplitude of floods and droughts. From the walkover survey, there is no evidence of any attempts at river channel modification on the main channel of the stream and no arterial drainage appears to have been carried out. The usual agricultural drainage schemes are in place; however, for the most part, they are not actively maintained and are attenuating sediment and nutrients. In summary, the traits described above combine to maintain this section of the watercourse in a highly natural state.

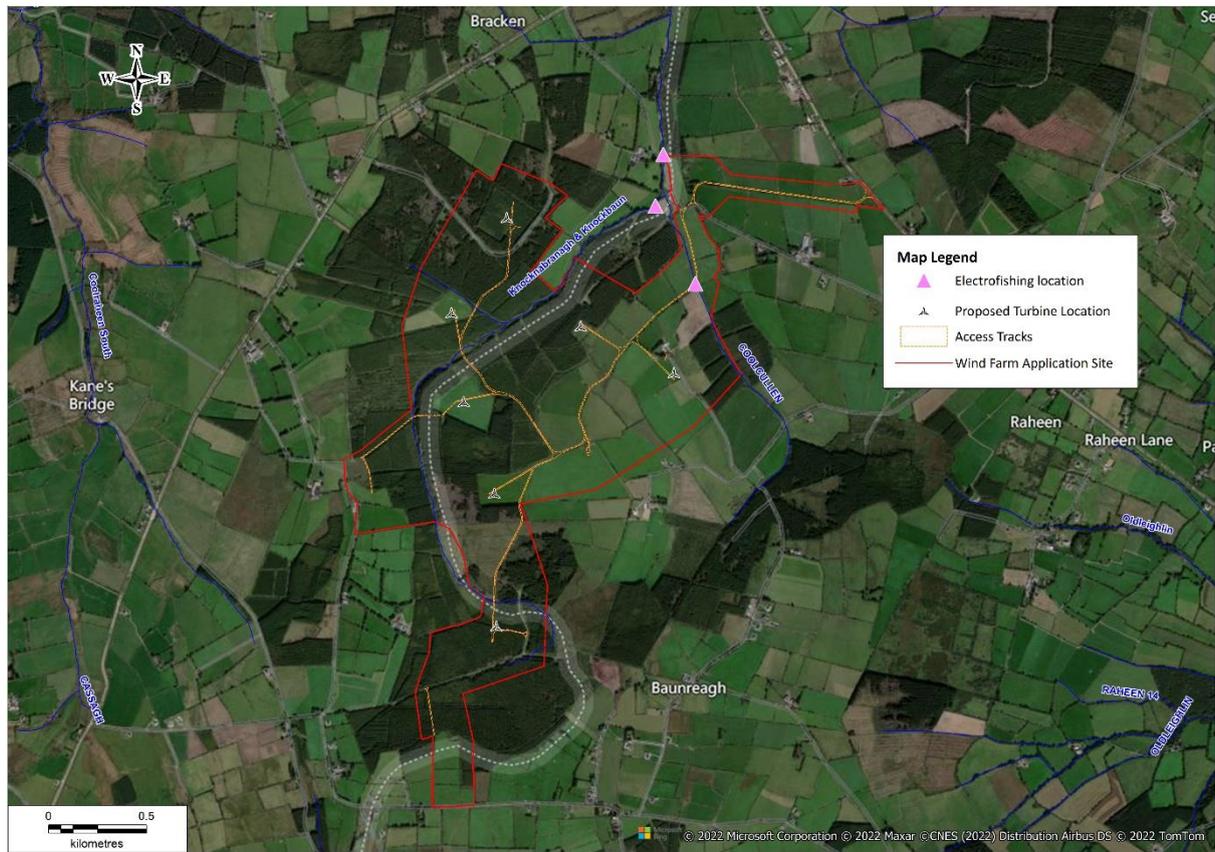
**Figure 5.18: Electrofishing Sites**

The Coolcullen River site was selected at the L7122 bridge crossing approximately 300m downstream of the confluence of the Coolcullen and Knocknabranagh & Knockbaun streams (**Figure 5.18**). The abiotic parameters at the sampling site are summarised in **Table 5.34**. Brown trout *Salmo trutta*, salmon *Salmo salar* and eel *Anguilla anguilla* were captured at this site. A single eel was captured and measured at 26.7cm. A total of 43 no. trout and 7 no. salmon were caught within a 30m stretch of river accounting for 105m<sup>2</sup> of river which was electrofished. This equates to 0.41 trout/m<sup>2</sup> and 0.04 salmon/m<sup>2</sup>. The average trout length was 6.24cm and the median was 5.8cm. The standard deviation for trout was 1.4 indicating that the age profile was quite limited. The average salmon length was 7cm and the median was 6.1cm. The standard deviation for salmon was 1.8 indicating that the age profile was varied. The age profile is shown in the graph below (**Figure 5.19**).

The electrofishing site on the Coolcullen Stream was selected 500m upstream of the confluence with the Knocknabranagh & Knockbaun Stream (**Figure 5.18**). The abiotic parameters at the sampling site are summarised in **Table 5.34**. Brown trout and salmon were captured at this site. A total of 37 no. trout and 4 no. salmon were caught within a 22m stretch of river accounting for 26.4m<sup>2</sup> of river which was electrofished. This equates to 1.4 trout/m<sup>2</sup> and 0.15 salmon/m<sup>2</sup>. The average trout length was 6.4cm and the median was 6.51cm. The standard deviation for trout was 0.89 indicating that the age profile was quite limited. The average salmon length was 5.65cm and the median was 5.45cm. The standard deviation for salmon was 0.65 indicating that the age profile was very limited. The age profile is shown in the graph below (**Figure 5.20**).

The electrofishing site on the Knocknabranagh & Knockbaun Stream was selected 50m upstream of the confluence with the Coolcullen Stream (**Figure 5.18**). The abiotic parameters at the sampling site are summarised in Table 5.34. Brown trout and salmon were captured at this site. A total of 24 no. trout and 7 no. salmon were caught within a 20m stretch of river accounting for 24m<sup>2</sup> of river which was electrofished. This equates to 1 trout/m<sup>2</sup> and 0.29 salmon/m<sup>2</sup>. The average trout length was 10cm and the median was 9cm. The standard deviation for trout was 4.42 indicating that the age profile was varied. The average salmon length was 5.6cm and the median was 5.6cm. The standard deviation for salmon was 0.38 indicating that the age profile was very limited. The age profile is shown in the graph below (**Figure 5.21**).

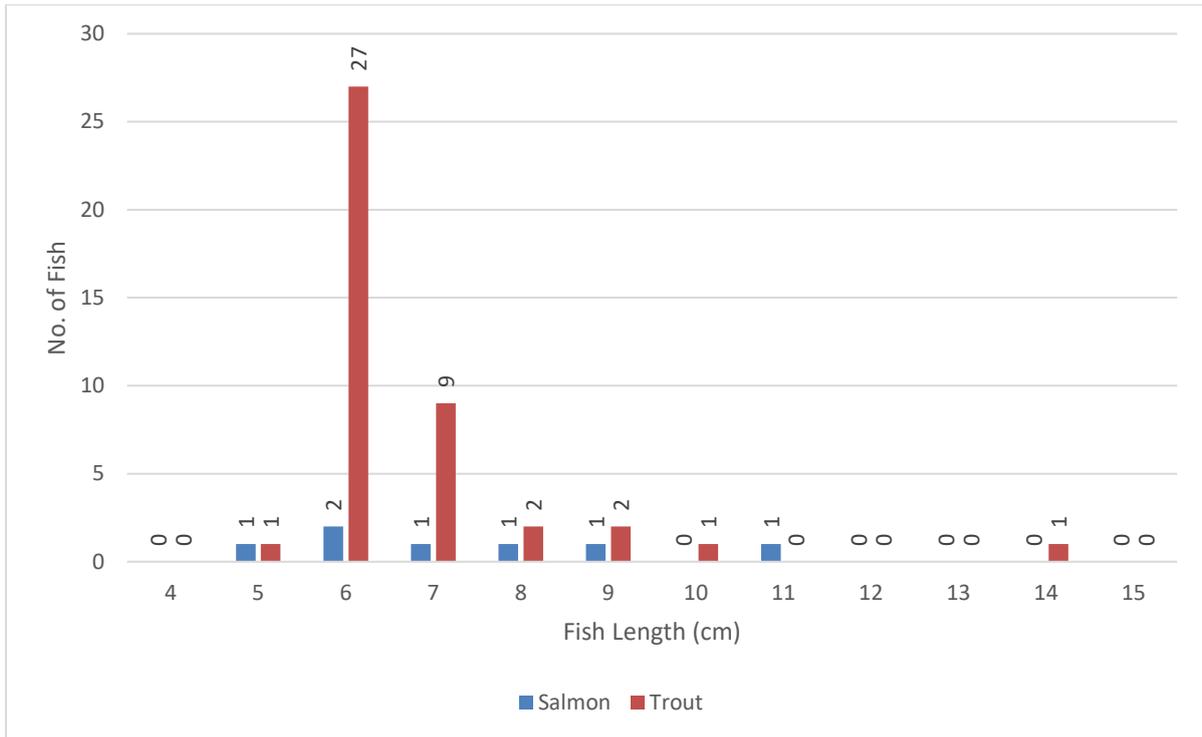
Figure 5.19: Age Profile of salmon and trout at Coolcullen River

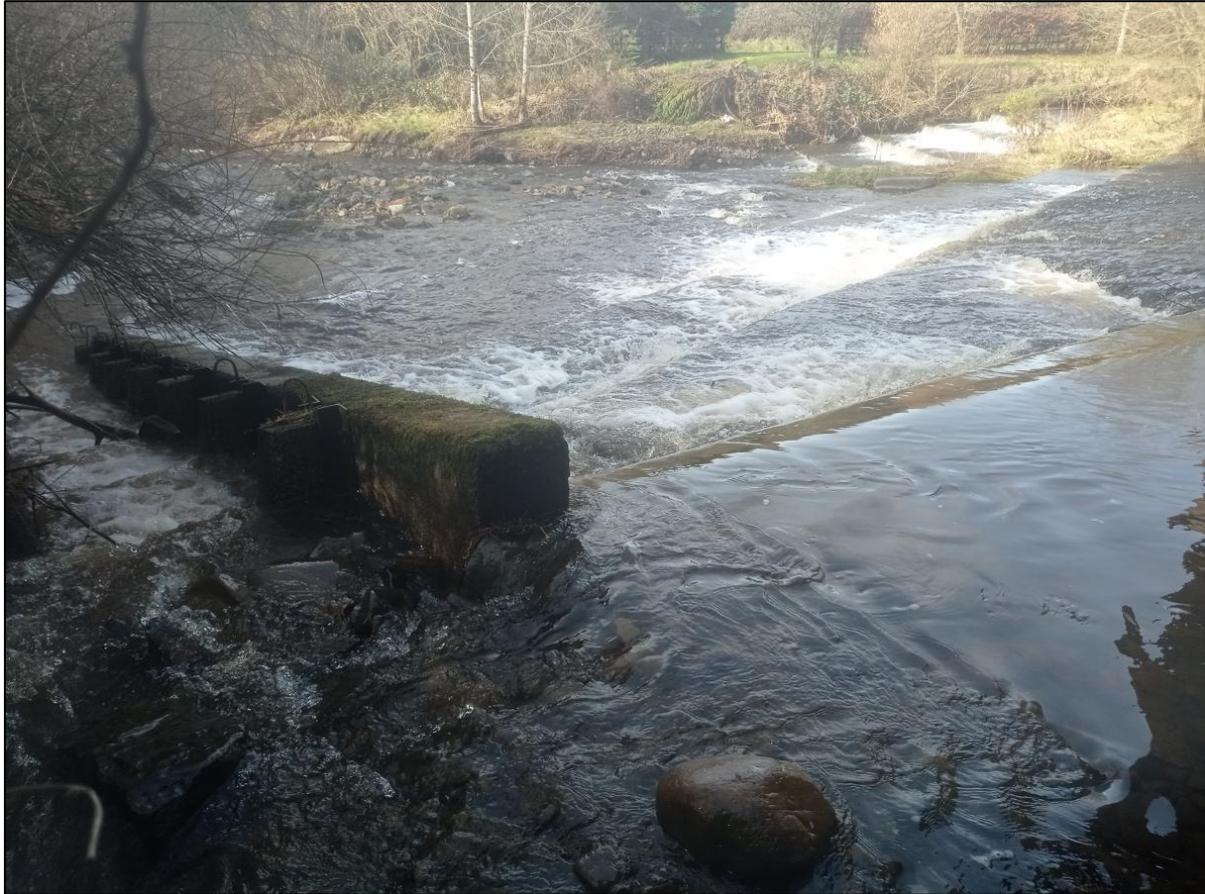
**Plate 5.19: Fish Pass and Bridge Apron at Coan Bridge**

Knockbaun Stream is in excellent condition hydromorphologically. There are riffles, pools and glides in optimal proportions, providing a good variety of habitats for juvenile salmonids. However, the stream is considered too small for spawning adult salmon. The electrofishing survey recorded relatively few Atlantic Salmon in the vicinity of the wind farm site. The likely reason for this, which was identified during the site walkover, and has also been identified by the Nore Suir River Trust<sup>5</sup>, is a fish passage issue at Coan Bridge, approximately 4km downstream of the project site. The apron of Coan Bridge is completely impassable to fish as it is a multi-tiered shallow laminar flow with no plunge pool on each tier to give migrating fish a break and to give them the depth needed to leap to the next tier. Therefore, passage at Coan Bridge depends completely on the fish pass, which is a Denil style fish pass.

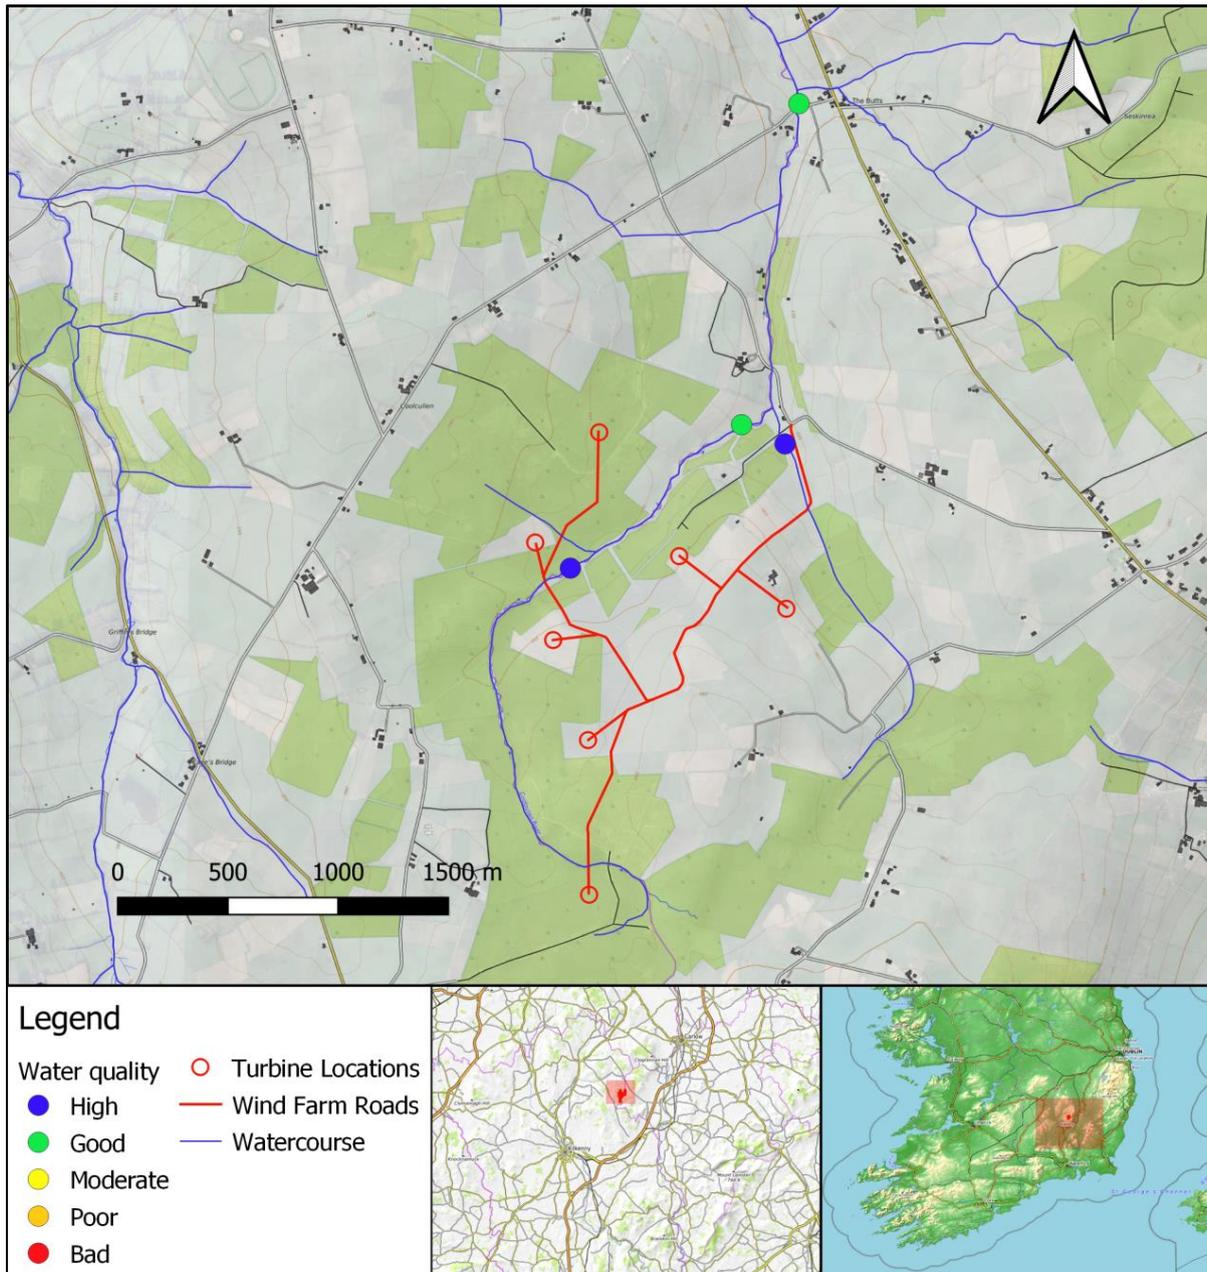
**Figure 5.22: Biological Water Quality Analysis within and downstream of the Wind Farm**

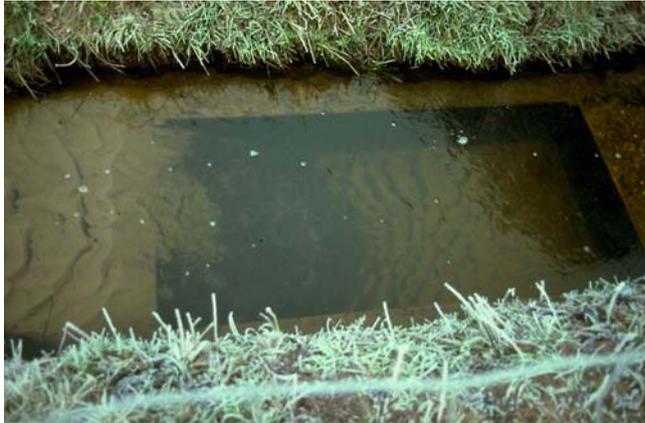
<sup>9</sup> [http://www.noresuirrivertrust.org/files/norebarriermigrationstudyver1\\_3.pdf](http://www.noresuirrivertrust.org/files/norebarriermigrationstudyver1_3.pdf)

Within the scope of the measurement program „quantifying load of sand and mud in heather creeks“ a sediment trap was installed in the Endeholz Ditch. The Endeholz Ditch is a small tributary of the Lutter river which has a catchment size of about 2.38 km<sup>2</sup> (HEUER-JUNGEMANN i. lit). Originally it was a small creek which has been extended to form a drainage ditch. About 10 m above it's confluence with the Lutter river a wooden box was installed in the river bottom (Fig. 1).

Fig. 13: Trend of sediment transportation in the Lutter. The amount has been measured in a sediment trap as shown in fig. 1. The success of the sediment trap "mill pond" and of the sediment traps in the drainage ditches is clearly seen.

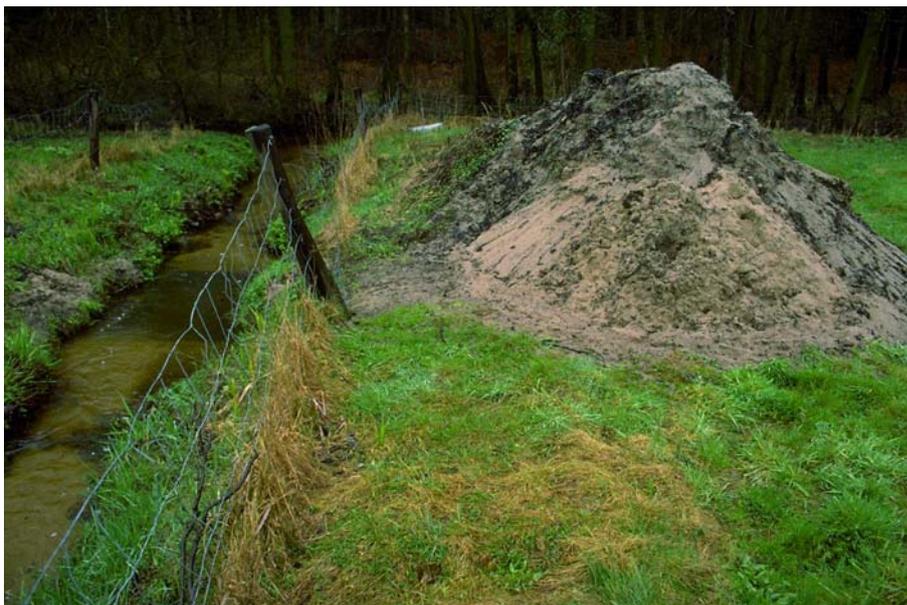
Fig. 2: Sediment trap in the Endeholz Ditch just before the confluence with the Lutter river (background) with the mound of sandy and organic material which was taken out of the trap from 1991 to 03. April 1998. The size of the mound shows the large amount of material carried by this small ditch.

From the end of 1991 to mid 2002 the sediment trap was emptied every week by young men who were doing their civilian service<sup>1</sup> (Zivildienstleistende = ZDL) in the nature conservation specialist agency of Lower Saxony. The amount of deposited material was measured as exactly as possible (Fig. 2).

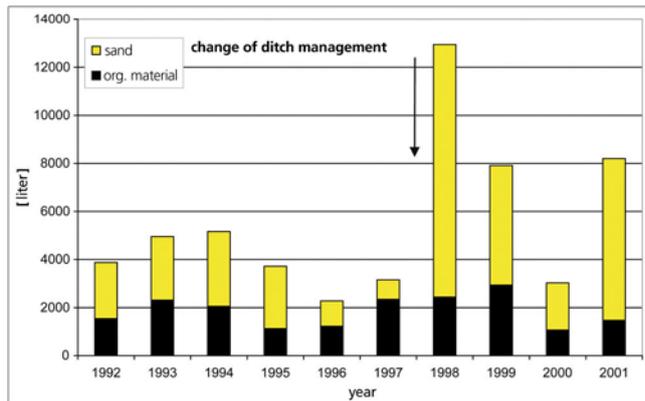
Fig 3: Annual sum of sediment load in the Endeholz Ditch. The change in the method of ditch management from hand clearance to machine clearance from the end of 1997 had a damaging effect on the ditch bottom and its banks, and the sediment load increased significantly. The amount of load after the maintenance of the ditch by machines was much higher than is shown in the figure as the sediment trap overflowed in the first weeks after that occasion.

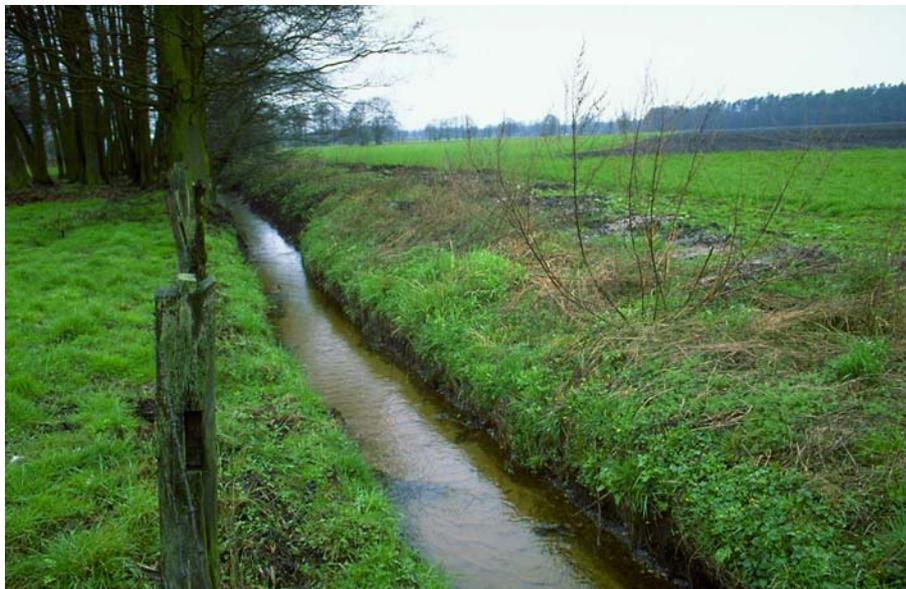
Fig. 4: The Endeholz Ditch in spring of 1998 after management by machines. On the right side the excavated material can be seen. The river bottom is exclusively sand. The ripples are characteristic of the moving sand.

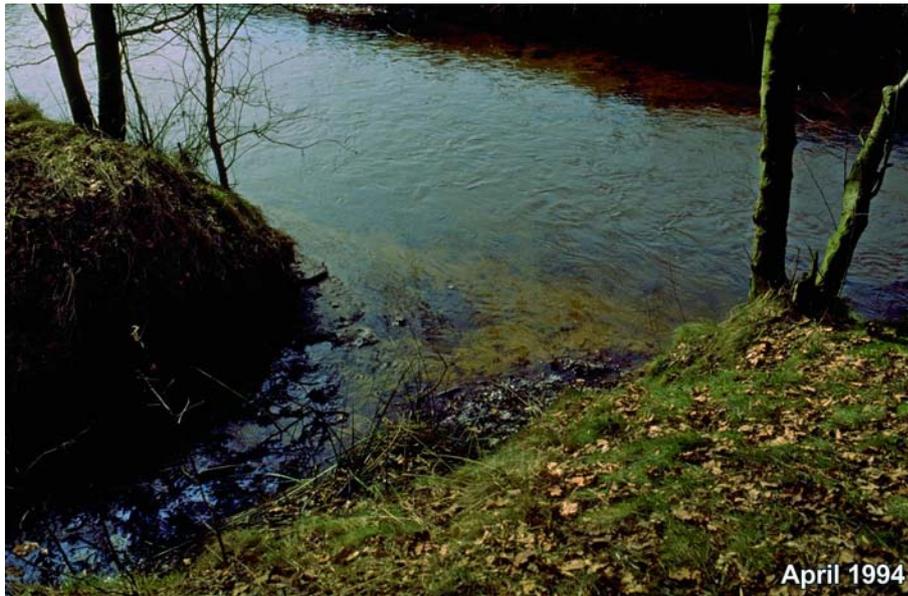
Fig. 5: Mouth of the Endeholz Ditch to the Lutter river in April 1994. At this time very little sand was transported into the Lutter river.

In Fig 3 the result of weekly emptying the sediment trap is shown as annual sums. The change of load amount from about 3.2 m<sup>3</sup> in the year 1997 to about 12.9 m<sup>3</sup> in the year 1998. Up to 1997 management of the Endeholz Ditch was carried out by hand but from autumn 1997 it was done using an excavator. The effect of the excavator was to loosen the sand from the banks and bed of the ditch and to transport it downstream. The authors only heard of this change from the young men who were doing their civilian service, who suddenly every week had to remove more than one m<sup>3</sup> out of the sediment trap. The figures 4 to 6 show the effect of this change.

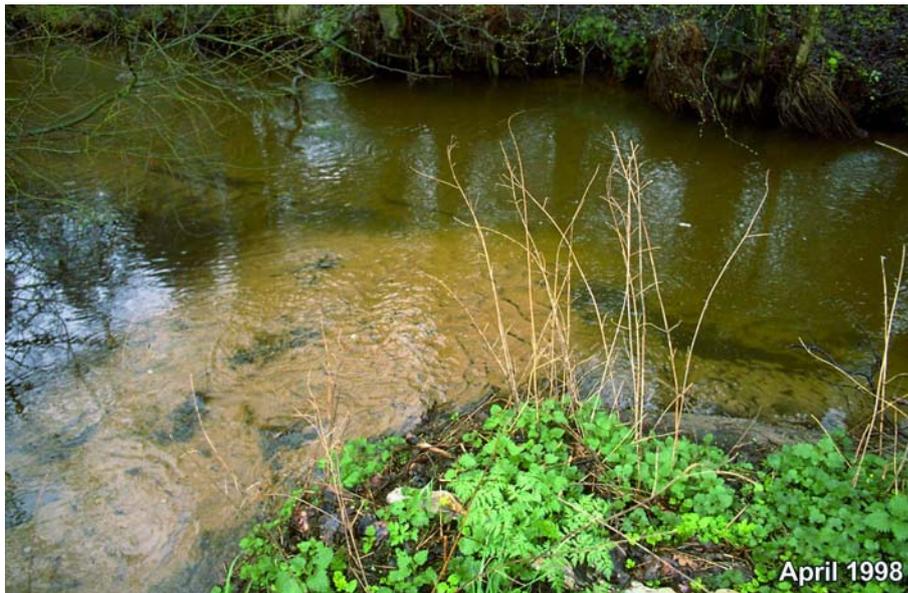
Fig. 6: Mouth of the Endeholz Ditch to the Lutter river on 03.04.1998. The large mass of sand which has been transported into the Lutter river after management of the ditch by machines is clearly seen. The sand which is seen here wasn't caught in the sediment trap 10 m upstream, because the trap was full. Therefore, the amount of load shown in Figure 3 for 1998 is an underestimate.

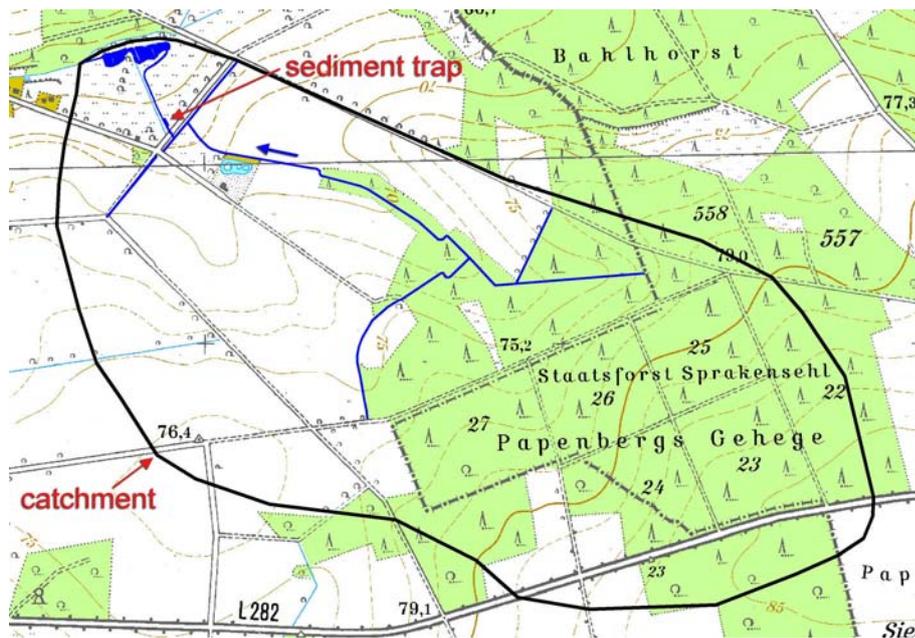
Fig.7: The sediment trap of Bargfeld (in the picture top on the left side) . The sediment trap is situated near a road and, therefore it is within easy and cost-effective reach by machines to empty it.

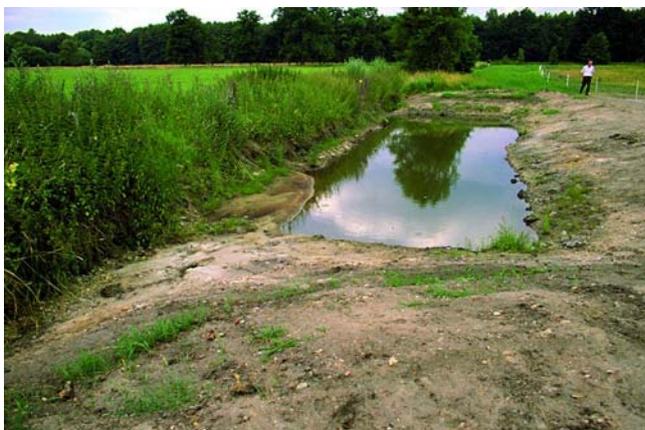
Fig. 9: View in flow direction of the „Sediment trap Bargfeld“ in summer of 1999 about one year after completion and after the first time of excavation. In front of the left side the mouth of the drainage ditch can be seen. At the far end on the left of the sediment trap the drainage ditch continues its flow through dense vegetation.

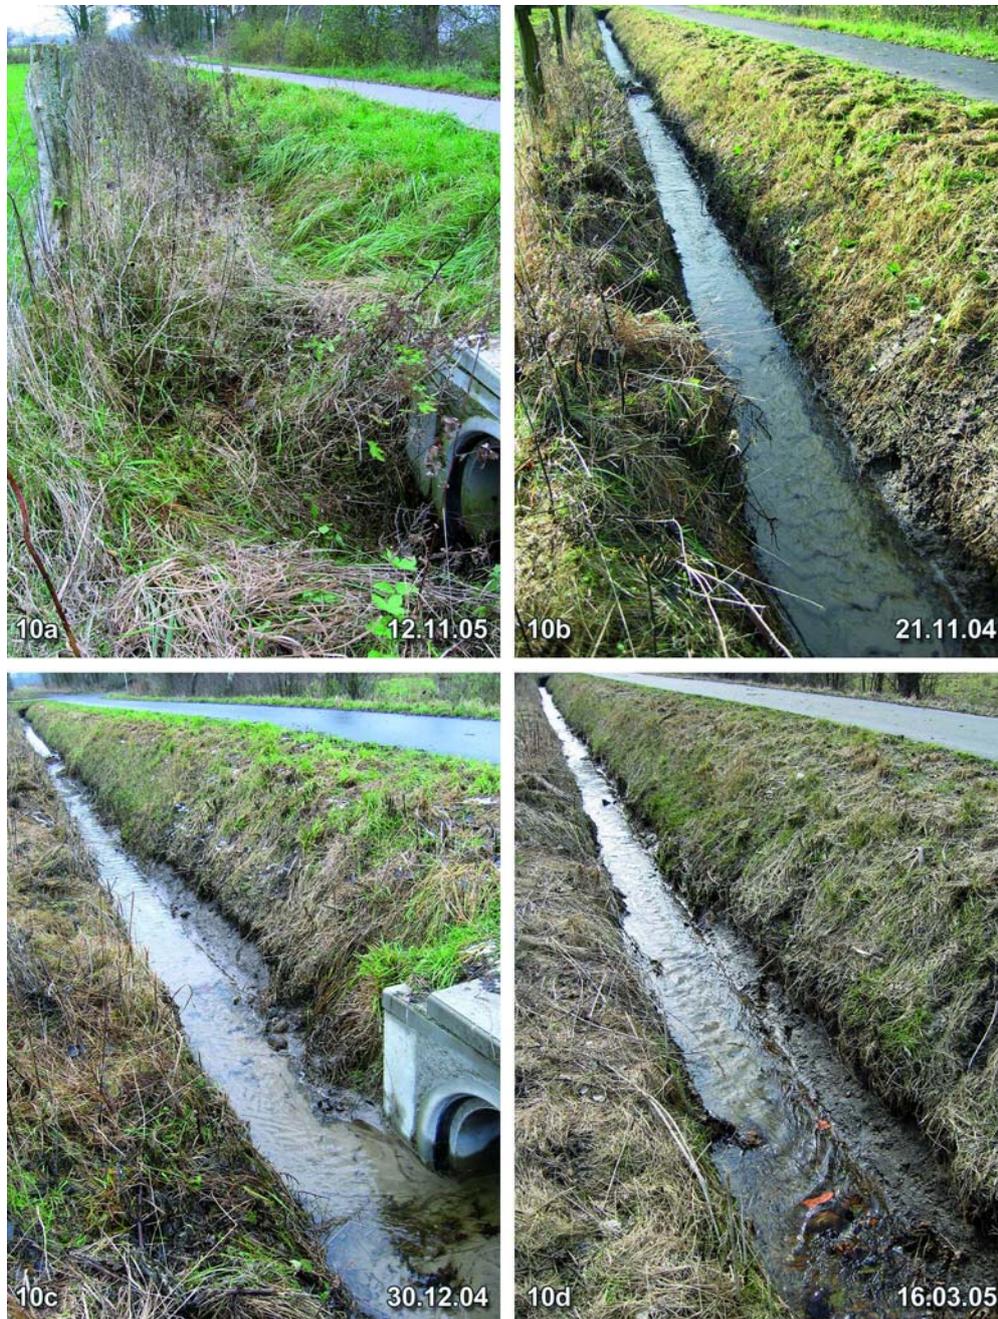
Fig. 10: Drainage ditch running parallel to the farm road. For position of the photographer see Fig. 8, top of the red arrow, view direction: sw.

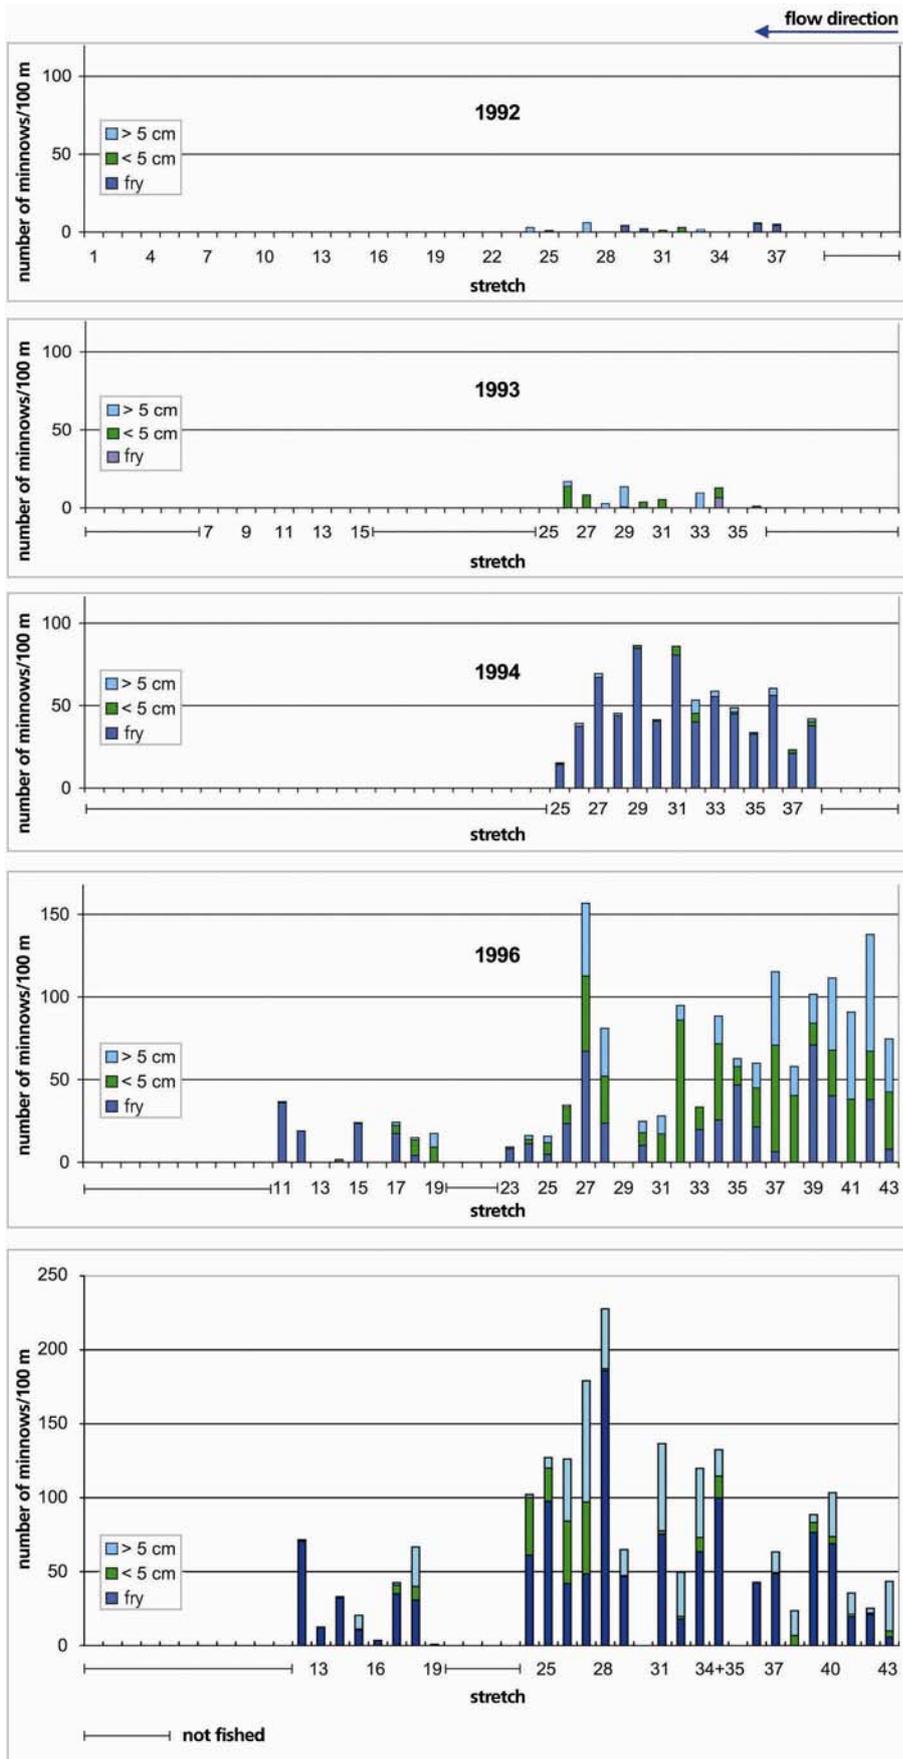
Fig. 16a-e: Development of the minnow population in the natural lower reaches of the river Lutter in the years 1992 - 1998. Sectors which were not investigated by electro fishing are shown by a line. Abschnitt = stretch; nicht befischte = not fished.

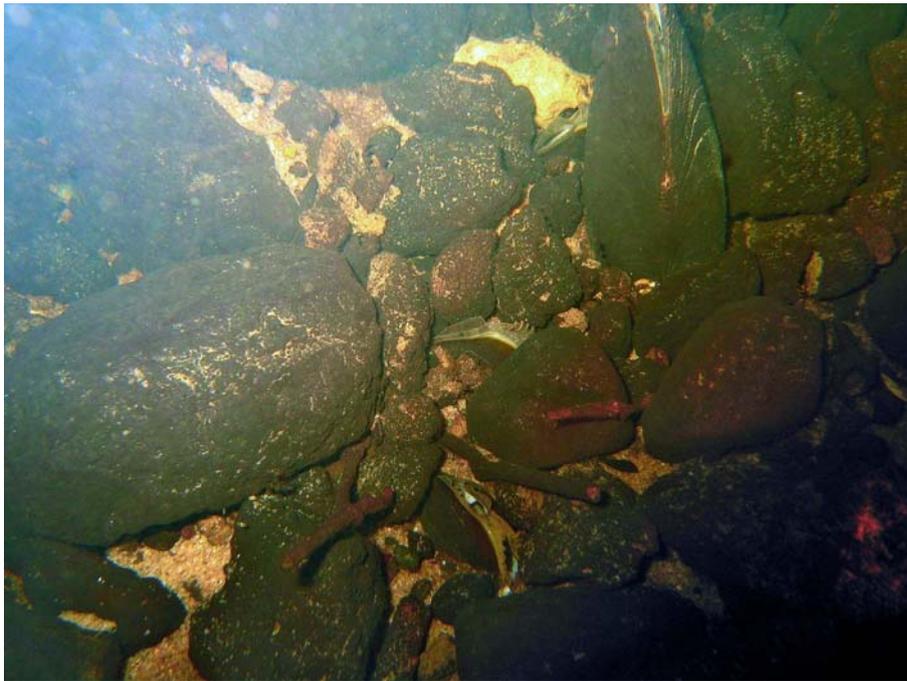
Fig. 17: River bottom of the Lutter with an adult FPM and three young mussels which are not easily seen between the gravel.

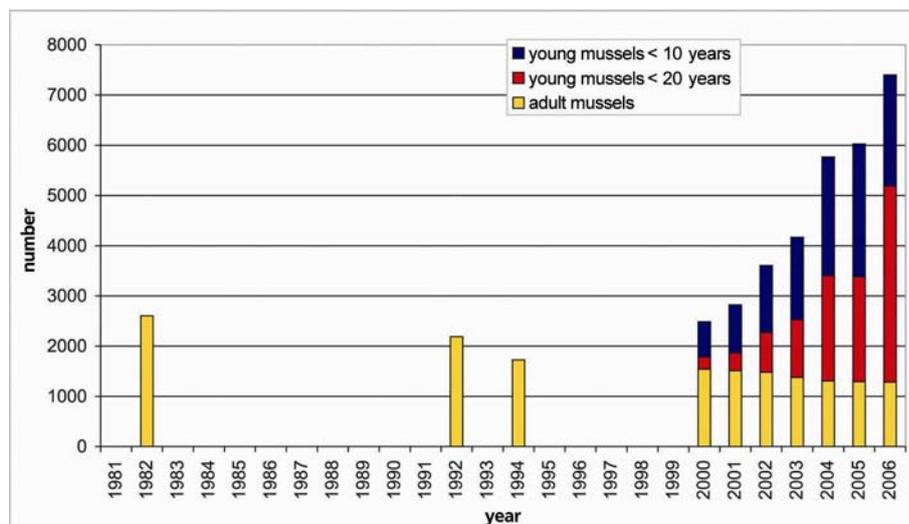
Fig. 18: Population development of the Freshwater Pearlmussels in the river Lutter. This positive trend is due to the reduction of the anthropogenic sand load since the upstream mill pond has not been drained off and therefore the sediments are no longer washed out of the mill pond.

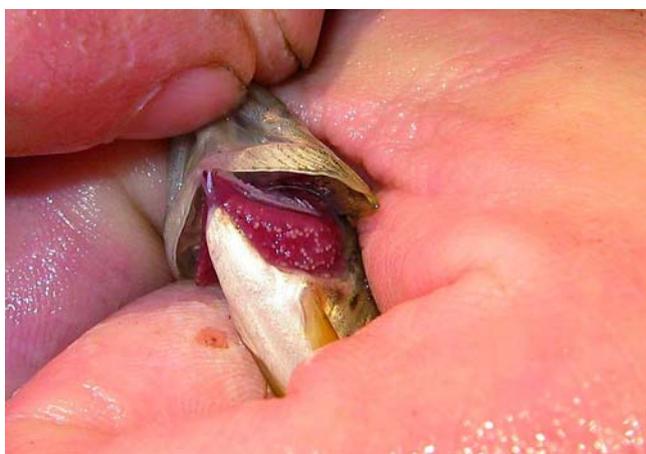
Fig. 19: Young brown trout of 2005 with nearly ripe young freshwater pearl mussels in the gills (light points) (result of electro fishing for monitoring - 07.05.2006). The glochidia are derived from young mussels which have matured after successful species and biotope protection measures. They will build up the F2 generation, but any success cannot be proven for another 5 – 7 years.

The long term survival of the FPM population in the river Lutter was given additional hope with the verification of the presence of young brown trout (*Salmo trutta f. fario*) in 2005 and 2006, which were naturally infected with FPM glochidia. (Fig. 19). Since the year 2003 no brown trout have been artificially infected with larva (glochidia) of the FPM in the natural lower reaches of the river Lutter. Furthermore, given that the oldest of the young FPM came to mature age and in view of such a large number of young mussels, natural infection of brown trout should be possible. However, to be certain of this, the artificial infection of brown trout with FPM glochidia must be stopped. The young infected brown trout which were found in 2005 and 2006 live in reaches of the river Lutter where only a few old FPM can be found. These few individuals produce too few glochidia to successfully infect brown trout. The high number of glochidia necessary for an intensive infection can only come from the high number of young mussels which are maturing at present.

The age composition of the infected brown trout is very interesting. Most of the infected fish examined in May of 2006 were born the previous year. They had been infected at an age of only a few months old. During the periods of artificial infection, fish this young were not utilised as they are very sensitive and easily damaged.

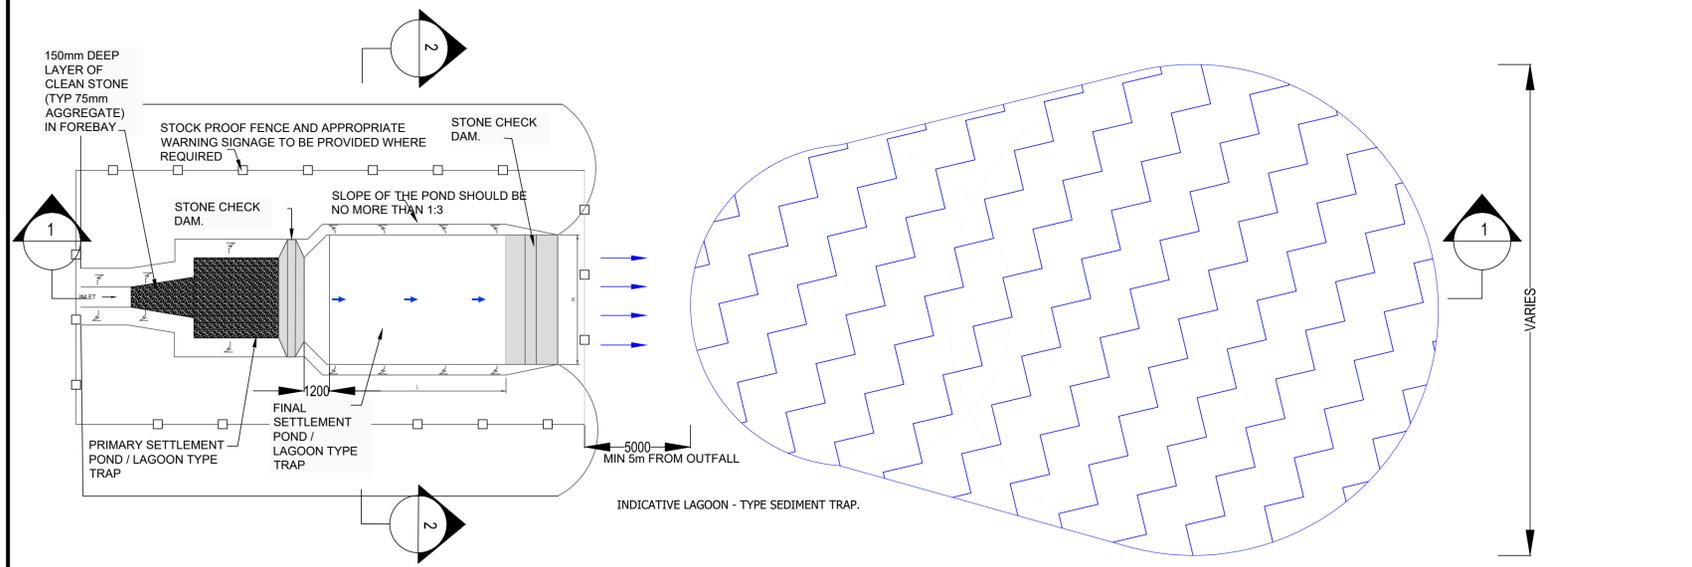
INDICATIVE SETTLEMENT POND / LAGOON - TYPE SEDIMENT TRAP DETAILS -  
SCALE N.T.S.
